AIRPROX REPORT No 2022127

Date: 03 Jul 2022 Time: 0917Z Position: 5128N 00119W Location: 4NM N Newbury

PART A: SUMMARY OF INFORMATION REPORTED TO UKAB

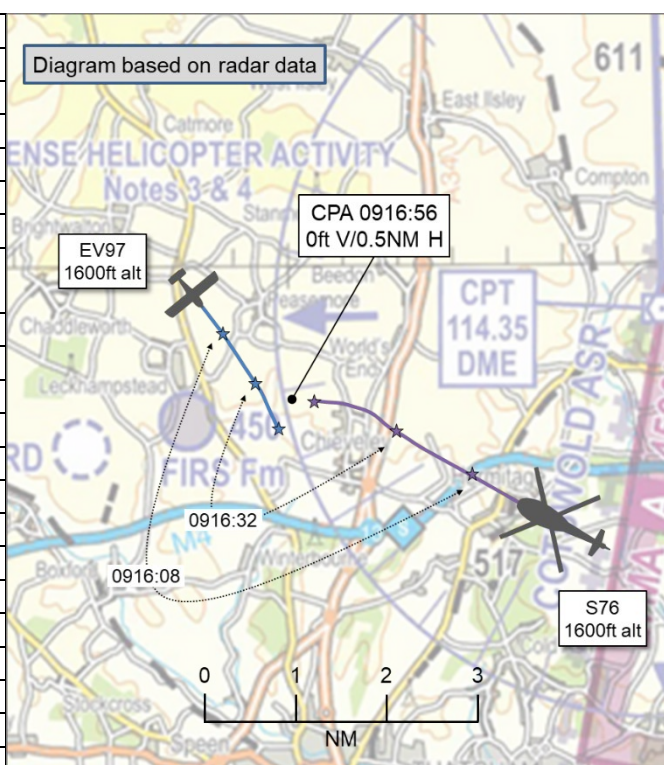
Recorded	Aircraft 1	Aircraft 2
Aircraft	EV97	S76
Operator	Civ FW	Civ Helo
Airspace	London FIR	London FIR
Class	G	G
Rules	VFR	VFR
Service	Listening Out	Traffic
Provider	Popham radio	Farnborough LARS West
Altitude/FL	1600ft	1600ft
Transponder	A, C, S	A, C, S
Reported		
Colours	Silver	Burgundy
Lighting	None	Landing, strobes
Conditions	VMC	VMC
Visibility	>10km	>10km
Altitude/FL	1300 to 1500ft	1600ft
Altimeter	NK (1019hPa)	QNH (NR hPa)
Heading	180°	315°
Speed	75kt	151kt
ACAS/TAS	Not fitted	TCAS I
Alert	N/A	Unknown
Separation at CPA		
Reported	50ft V/100m H	50ft V/0.5NM H
Recorded	0ft V/0.5NM H
