AIRPROX REPORT No 2022139

Date: 13 Jul 2022 Time: ~1106Z Position: 5249N 00247W Location: Sleaf ATZ

PART A: SUMMARY OF INFORMATION REPORTED TO UKAB

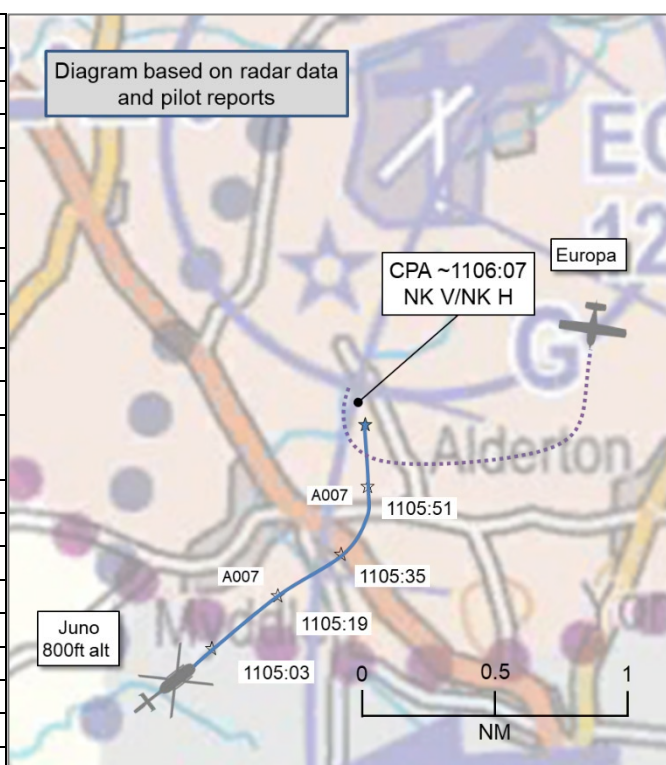
Recorded	Aircraft 1	Aircraft 2
Aircraft	Juno	Europa
Operator	HQ Air (Trg)	Civ FW
Airspace	Sleaf ATZ	Sleaf ATZ
Class	G	G
Rules	VFR	VFR
Service	AGCS	AGCS
Provider	Sleaf Radio	Sleaf Radio
Altitude/FL	800ft	NK
Transponder	A, C, S	None ¹
Reported		
Colours	Black, Yellow	White
Lighting	Nav, Strobe, Anti-col, Landing	None
Conditions	VMC	VMC
Visibility	>10km	>10km
Altitude/FL	800ft	NK
Altimeter	QFE (1014hPa)	QFE (NK hPa)
Heading	360°	'On Final'
Speed	60kt	80kt
ACAS/TAS	ACAS	Not fitted
Alert	None	N/A
Separation at CPA		
Reported	20-30ft V/80-100ft H	Not seen
Recorded	NK V/NK H
