AIRPROX REPORT No 2022147

Date: 23 Jul 2022 Time: 1534Z Position: 5205N 00051W Location: 9NM W Cranfield

PART A: SUMMARY OF INFORMATION REPORTED TO UKAB

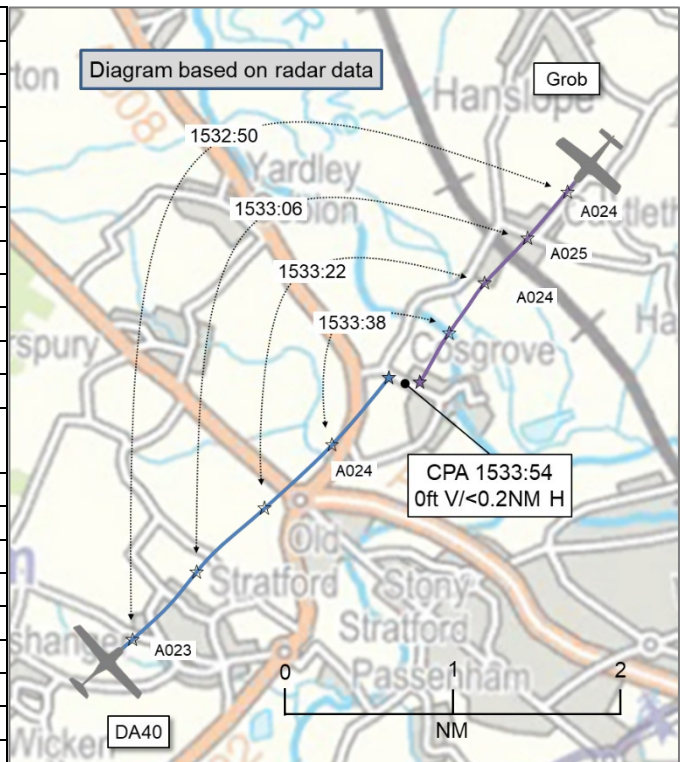
| Recorded | Aircraft 1 | Aircraft 2 |
|---|---|---|
| Reported | 0ft V/200m H | Not seen |
| Recorded | 0ft V/<0.2NM H | |

THE DA40 STUDENT PILOT reports that the cloud was overcast at high level, meaning that the other aircraft was against a white background. It had thin wings and was painted white, making it very difficult to see. Additionally, the fact that it was straight ahead and opposite direction meant that there was no movement in their field of vision until it got as close as it did. It was their first solo navigation flight, and just prior to seeing the aircraft they had been briefly referencing their chart.

The DA40 student pilot added that both pilots made a very slight left turn. Although SERA states to turn right when head-on, because both were slightly to the right of each other and saw each other late, it made sense to turn left. They wouldn't have collided if they had both continued on track, but a slight instinctive left turn was made to ensure more separation. There would have been risk of collision if the standard right turn was made.
