AIRPROX REPORT No 2022141

Date: 16 Jul 2022 Time: 0855Z Position: 5558N 00356W Location: Cumbernauld

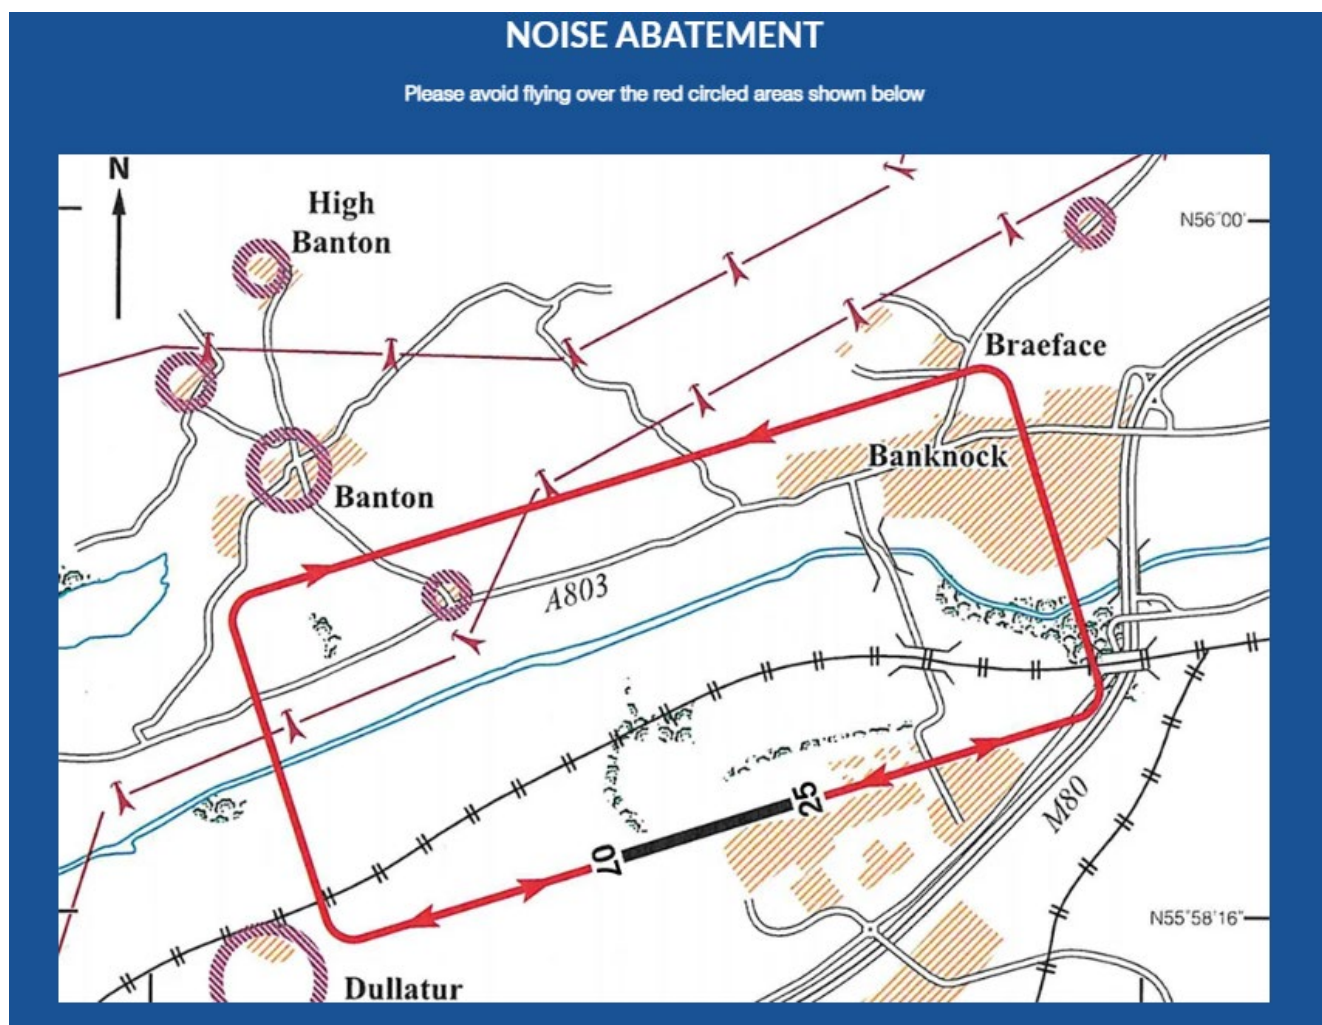
Figure 1: Cumbernauld circuit diagram

The Cumbernauld website provided the following circuit diagram and noise abatement information:

a. Circuit directions: Runway 25 - RH; Runway 07 - LH for all circuit traffic. Circuit height: 800 FT QFE.
