**AIRPROX REPORT No 2022153**

Date: 01 Aug 2022 Time: 1049Z Position: 5413N 00115W Location: 1.7NM WSW Sutton Bank

**PART A: SUMMARY OF INFORMATION REPORTED TO UKAB**

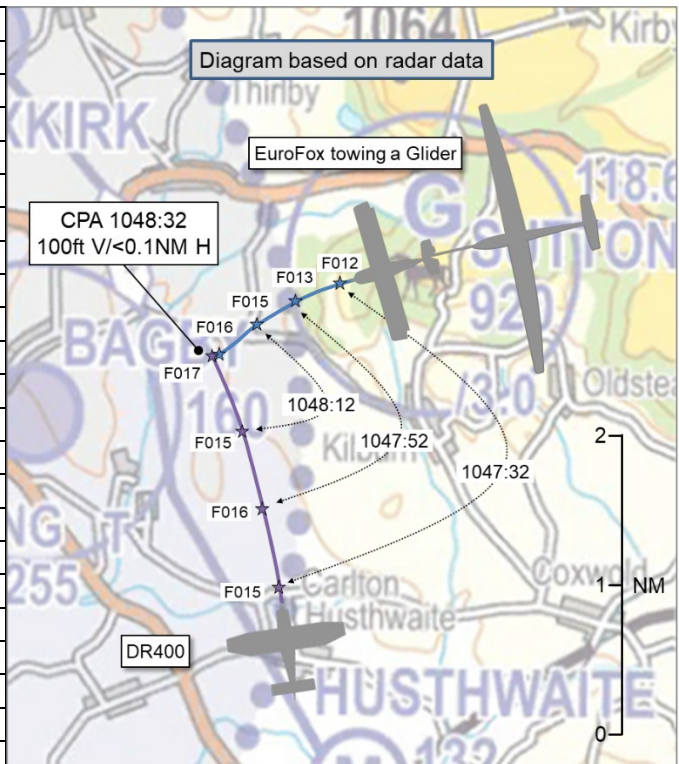
**THE EUROFOX PILOT** reports that a DR400 was sighted as it appeared from behind the Eurofox’s high-wing. The DR400 passed 50m in front and less than 50ft above. The glider pilot (being towed 50m behind the Eurofox) reported that the DR400 jinked left just prior to closest conflict. The DR400 registration was clearly visible on the left side of the aircraft as it diverged away to the right of the Eurofox after the conflict. The Eurofox pilot reports that there was no time to take avoiding action.

They had explained the difficulty of seeing gliders (and all aircraft) to their passenger who was the first to see the tug and glider in the one o’clock position and 70ft below. They opined that their scan had been too focused above and to the east. They note that they had deliberately not gone higher than 1600ft (on 1019hPa) so as to stay out of the airspace that gliders might be in, and to remain well clear of cloud. This, they opined, was misjudged and had clashed with the circuit [at Sutton Bank]. They

The investigator reaffirmed the original investigation summary that only a primary contact was observed and only at the moment of convergence with the DR400 on the radar display. They reported that the 0034 squawk did not become visible until after the DR400 pilot had reported clear of the gliders.
