AIRPROX REPORT No 2022154

Date: 02 Jun 2022 Time: 1557Z Position: 5130N 00015W Location: 3.5NM NW London Heliport

PART A: SUMMARY OF INFORMATION REPORTED TO UKAB

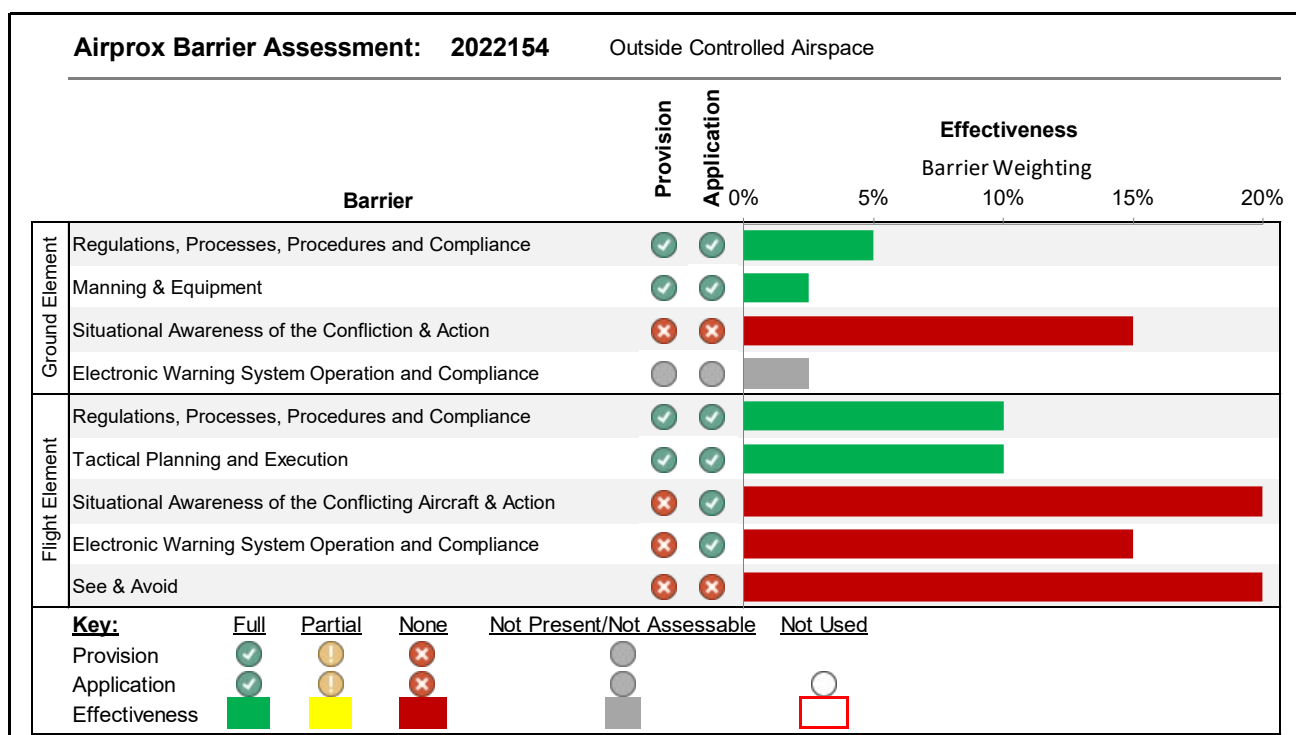
Electronic Warning System Operation and Compliance were assessed as **ineffective** because the TAS fitted to the A109 had been unable to detect, and had therefore been incompatible with, the Mavic Pro 2.

See and Avoid were assessed as **ineffective** because, although both pilots had become visual with the other aircraft, this had only occurred at CPA when it had been too late for them to have taken any effective avoiding action.
