AIRPROX REPORT No 2022150

Date: 27 Jul 2022 Time: 1135Z Position: 5411N 00113W Location: 6NM E of Topcliffe

PART A: SUMMARY OF INFORMATION REPORTED TO UKAB

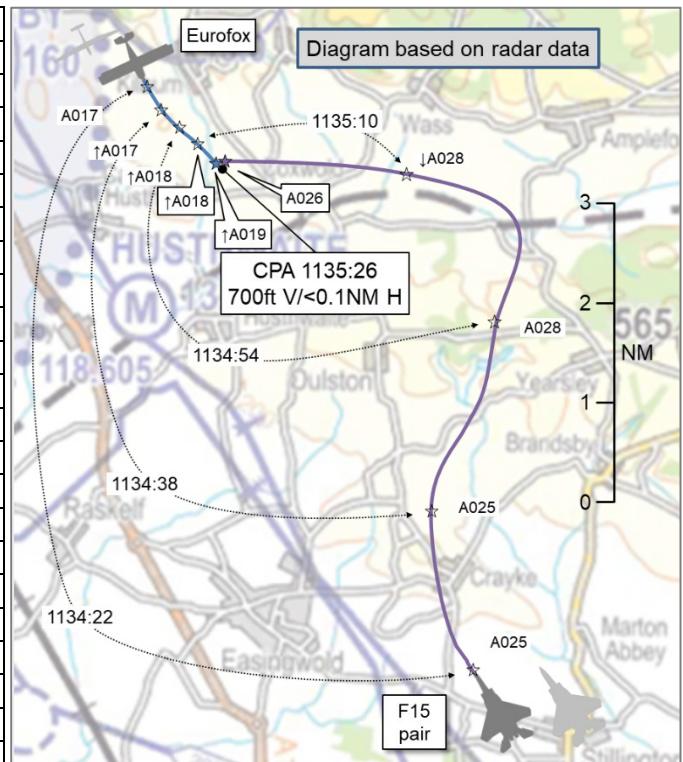
THE EUROFOX PILOT reports that two F15s were sighted turning on to a westerly heading overhead Gilling, approximately 5NM east of Sutton Bank. The pair rolled out in fighting wing formation and closed rapidly from left-to-right but with relative movement astern of the tug/glider combination. Avoiding action was deemed unnecessary, and the F15 pair passed behind with horizontal separation from the tug of 300-400m (the glider on tow was 50m behind the tug). The F15s were flying with a small height split, and the formation passed astern the combination with zero height difference. The Airprox was reported to RAF Leeming and Leeming ATC also reported the incident which had been observed on radar. A NOTAM had been issued concerning the fast-jet activity around RAF Topcliffe, and the gliding operation at Sutton Bank (Yorkshire Gliding Club) was set up to launch to the southeast of the site in order to minimise flying in the NOTAM'd airspace.

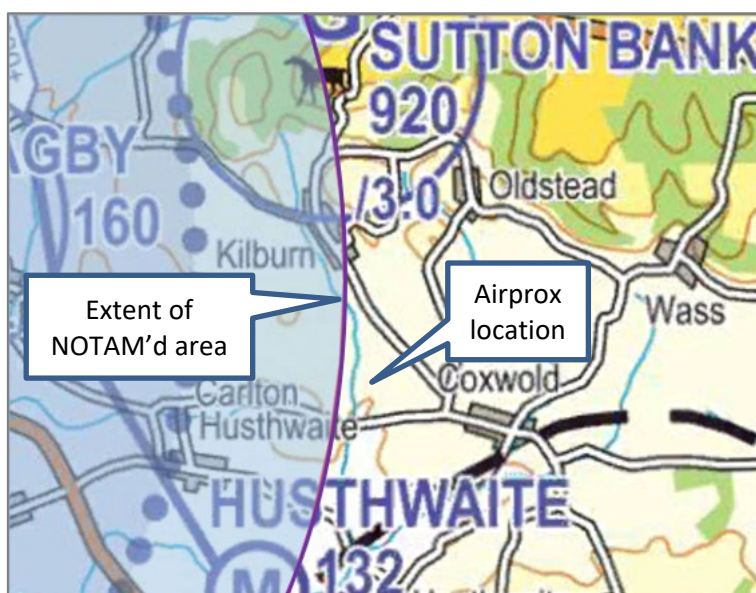
In the lead-up to the Airprox the Eurofox was recorded maintaining a reasonably constant heading and a slow steady climb. The F15s could be seen to be operating in an altitude band between 2500ft and 2800ft, with a groundspeed in the region of 400kt. The minimum distance between the Eurofox and the lead F15 observed on the radar, radar CPA, was 0.1NM horizontally and 700ft vertically, see Figure 6. However, the lead F15 went on to pass behind the Eurofox, resulting in the actual horizontal separation being less than that recorded by the radar and as such has been recorded as <0.1NM.
