## AIRPROX REPORT No 2022158

Date: 04 Aug 2022 Time: 1525Z Position: 5210N 00046W Location: ivo OLNEY VRP

### PART A: SUMMARY OF INFORMATION REPORTED TO UKAB

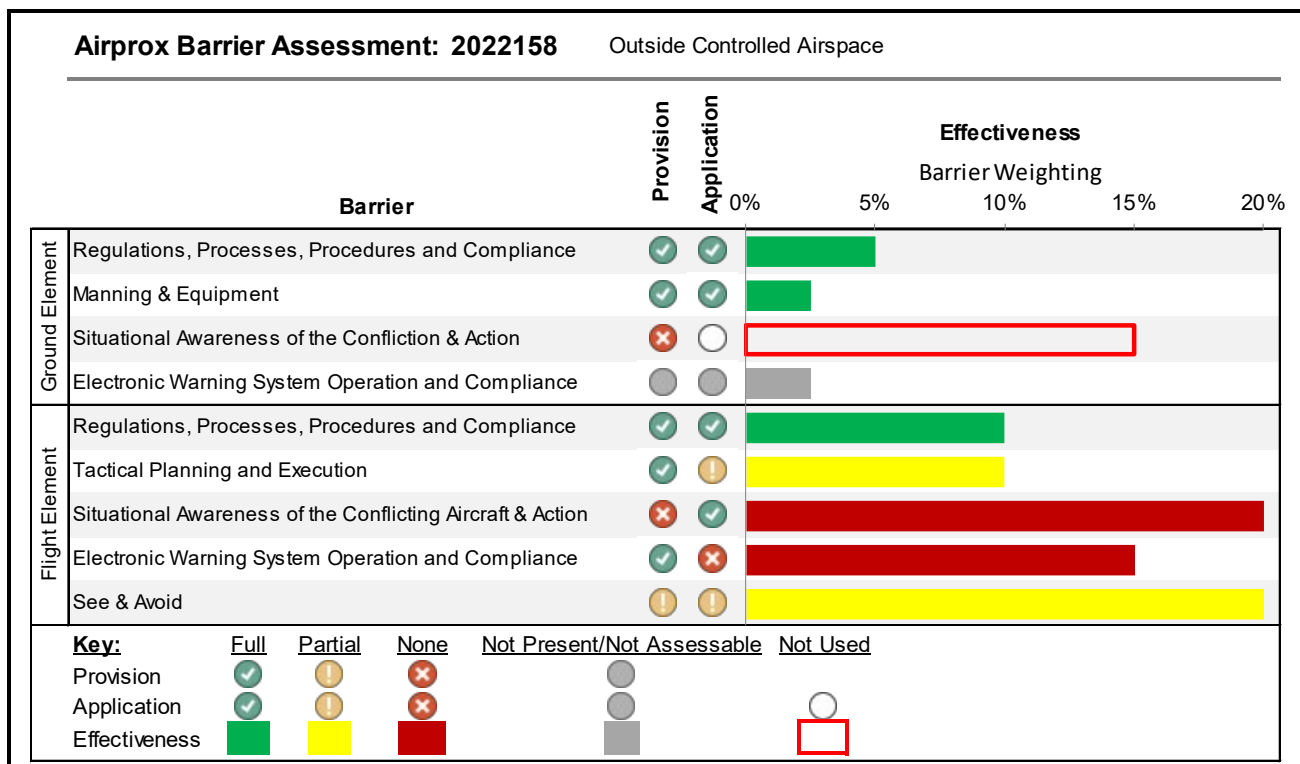
**Electronic Warning System Operation and Compliance** were assessed as **ineffective** because although the aircraft's TAS were compatible, neither alerted.

**See and Avoid** were assessed as **partially effective** because although the ASG29 pilot did not see the T67, the T67 pilot saw the glider at a late stage and took action to ensure separation.
