AIRPROX REPORT No 2022160

Date: 04 Aug 2022 Time: 1622Z Position: 5121N 00142W Location: 3.5NM S Marlborough

PART A: SUMMARY OF INFORMATION REPORTED TO UKAB

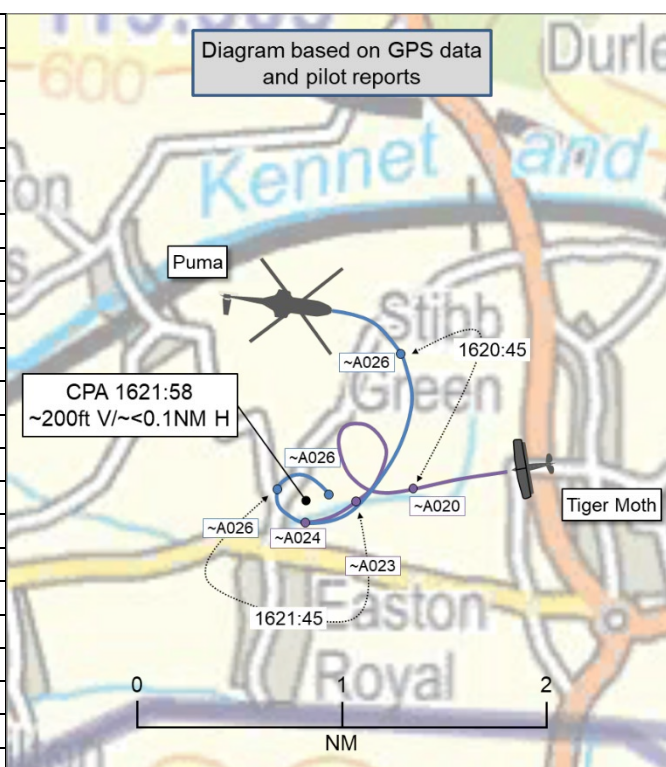
Recorded	Aircraft 1	Aircraft 2
Aircraft	Puma HC2	DH82A Tiger Moth
Operator	HQ JHC	Civ FW
Airspace	London FIR	London FIR
Class	G	G
Rules	VFR	VFR
Service	Listening Out	None
Provider	Salisbury Ops	N/A
Altitude/FL	~2600ft	~2400ft
Transponder	A, C, S	Not fitted
Reported		
Colours	Green, grey, red	Green, silver
Lighting	NR	None
Conditions	VMC	VMC
Visibility	>10km	>10km
Altitude/FL	2200ft	2000ft
Altimeter	QNH (NR hPa)	QNH (NK hPa)
Heading	90°	260°
Speed	100kt	75kt
ACAS/TAS	TAS	Not fitted
Alert	None	N/A
Separation at CPA		
Reported	0ft V/150m H	200ft V/200m H
Recorded	~200ft V/~<0.1NM H

THE PUMA PILOT reports that they were in transit, under VFR and at low level, to [destination] within D128 of the Salisbury Plain Training Area (SPTA) for confined area landings. On entering the Low Flying Area, they attempted to contact Middle Wallop but were unable to raise them. Instead, an information call was transmitted blind and they continued to the SPTA, gaining clearance from Salisbury Ops on UHF before entering the [destination area] to conduct training as planned. On completion, the Puma departed to the north to identify a suitable site in the vicinity of Burbage to conduct autorotations and PFLs. Due to the lack of communication with Middle Wallop, the crew informed Salisbury Ops that they would remain on frequency for a listening watch. On identifying a suitable field, HASELL checks were completed while climbing to 2200ft. The captain briefed that a 180° lookout turn would be flown before entering the PFL. During the lookout turn, the crewman identified an intruding aircraft in the 3 o'clock position at the same level and transiting in the opposite direction. No TAS alert was provided to the crew. The pilot visually acquired the aircraft (a vintage biplane type) at an estimated 1NM range, and the Puma pilot elected to continue to orbit to ensure safe separation prior to conducting the PFL.

As the Puma pilot continued the orbit to the right, the other aircraft turned towards them, reducing the separation distance. As the Puma continued into a second orbit, the other aircraft tightened its turn, positioning itself in the 4-5 o'clock position from the Puma, and pointing towards the Puma with decreasing range. As it got closer to the limit of the Puma crew's field of view, the Puma pilot tightened their turn in order to maintain visual contact and to attempt to force the chasing aircraft to discontinue its manoeuvre. On doing so, the chasing aircraft also tightened its turn, further reducing the separation. This continued for approximately 4 orbits [they recall], with the chasing aircraft adjusting its angle-of-bank to keep the Puma aircraft in its 12 o'clock position throughout. It was the shared opinion of the Puma crew that the other aircraft seemed to be attempting to 'tailchase' the Puma. At its closest, the other aircraft was an estimated 6-10 rotor spans (100-150m) and the captain was able to read the aircraft registration from the fuselage. As the Puma crew discussed the situation and their options, the

other aircraft eventually broke off its chase, turning left behind the Puma and departing the area. The Puma crew continued with their planned sortie.
