**AIRPROX REPORT No 2022166**

Date: 04 Aug 2022 Time: 1355Z Position: 5155N 00130W Location: 2NM SE Chipping Norton

**PART A: SUMMARY OF INFORMATION REPORTED TO UKAB**

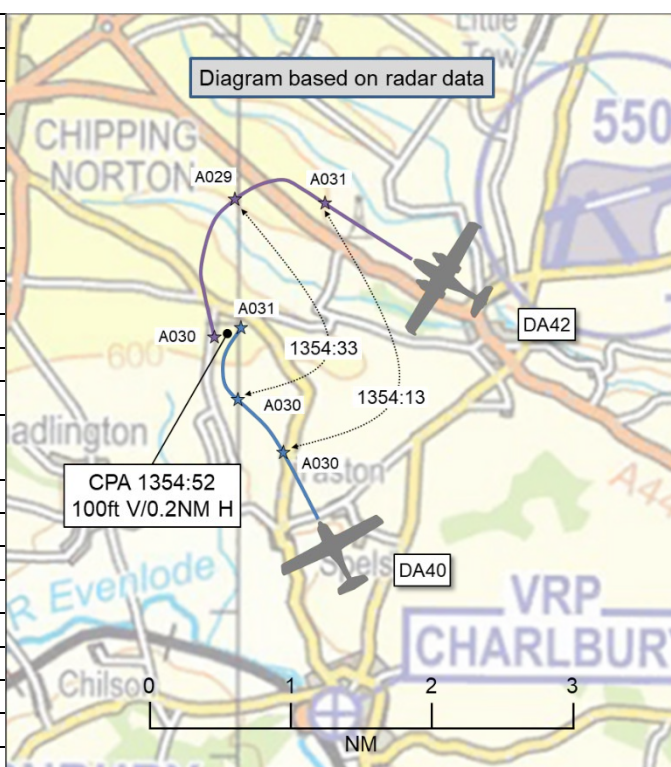
Recorded	Aircraft 1	Aircraft 2
Aircraft	DA40	DA42
Operator	Civ FW	Civ FW
Airspace	London FIR	London FIR
Class	G	G
Rules	VFR	VFR
Service	Basic	Traffic
Provider	Oxford Radar	Oxford Radar
Altitude/FL	3100ft	3000ft
Transponder	A, C, S+	A, C, S+
<b>Reported</b>		
Colours	White	White
Lighting	Landing, taxi, position, strobes	Landing, position, strobes
Conditions	VMC	VMC
Visibility	>10km	>10km
Altitude/FL	3000ft	NK
Altimeter	QNH (1016hPa)	QNH (NK hPa)
Heading	340°	NK
Speed	100kt	NK
ACAS/TAS	Not fitted	TAS
Alert	N/A	None
<b>Separation at CPA</b>		
Reported	<100ft V/<100m H	NK V/NK H
Recorded	100ft V/0.2NM H
