AIRPROX REPORT No 2022207

Date: 01 Sep 2022 Time: 1233Z Position: 5135N 00106W Location: Benson

PART A: SUMMARY OF INFORMATION REPORTED TO UKAB

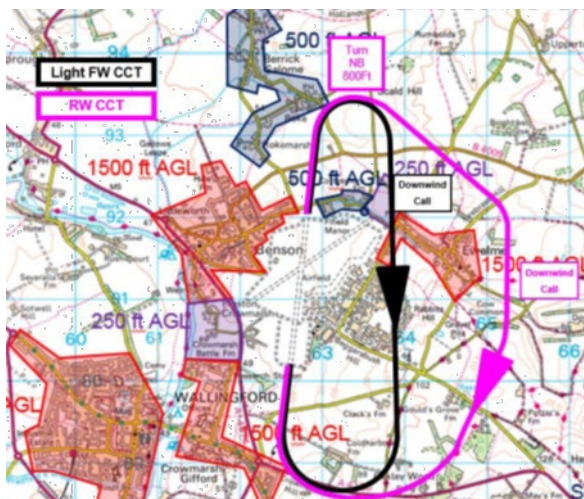
Figure 2: RAF Benson Visual Circuit profile RW01RH and Local Avoids.

Following review of RAF Benson's Defence Aerodrome Manual both the Merlin and Tutor were operating in accordance with the policy at the time of Airprox. Figure 3⁵ above represents the profile expected of a helicopter conducting an underslung load circuit, however, as stated in the Defence Aerodrome Manual these are notional circuits and may be amended to suit wind conditions.

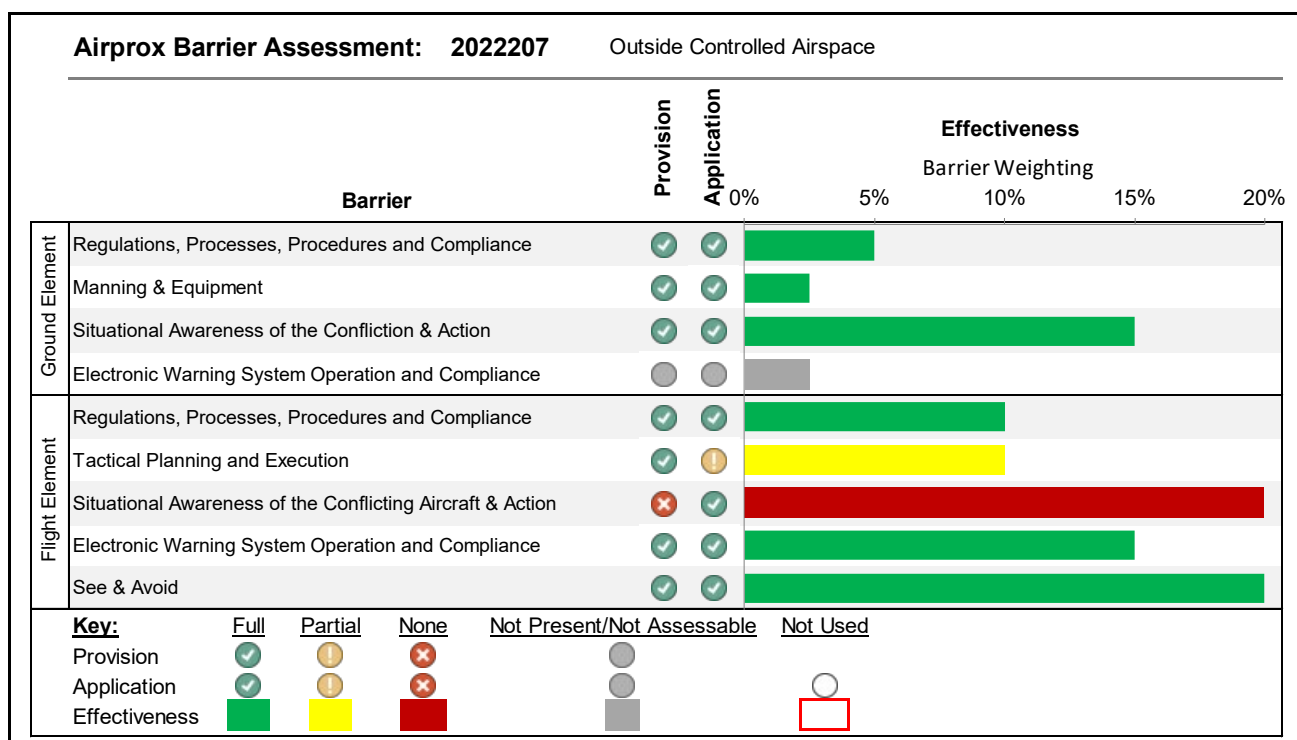
Tactical Planning and Execution was assessed as **partially effective** because the Merlin crew did not adapt their plans to take into account the poor radio performance.

Situational Awareness of the Conflicting Aircraft and Action were assessed as **ineffective** because the Merlin crew was not aware that the Tutor was joining through Initials.
