AIRPROX REPORT No 2022215

Date: 18 Sep 2022 Time: 1700Z Position: 5216N 00013E Location: 3.5NM NNE Cambridge

PART A: SUMMARY OF INFORMATION REPORTED TO UKAB

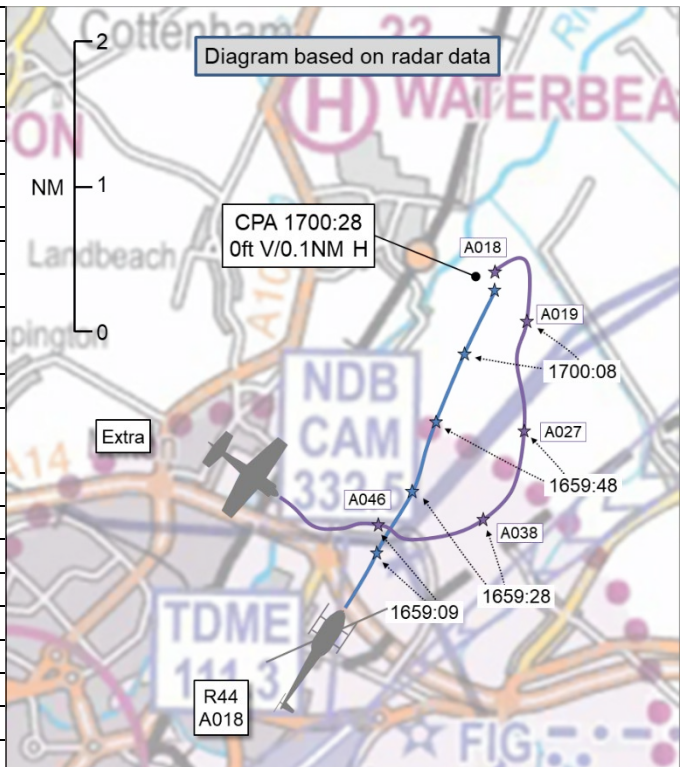
An analysis of the NATS radar replay was undertaken and both aircraft could be identified from Mode S data. The diagram was constructed and the CPA determined from the radar data. The aircraft were observed on radar to be at Flight Levels. The QNH passed to the R44 pilot was 1019hPa.

The moment of CPA occurred as the pilot of the Extra had flown across the track of the R44 whilst still trailing smoke. Members noted that the pilot of the Extra reported that they had maintained visual contact with the R44 throughout the encounter and were in agreement that, as such, the overtaking manoeuvre had not been conducted adequately to 'keep out of the way of the aircraft being overtaken' (**CF7**). It was further agreed that the pilot of the Extra had flown close enough to the R44 to have caused its pilot concern (**CF9**).
