AIRPROX REPORT No 2022257

Date: 18 Oct 2022 Time: 1136Z Position: 5553N 00424W Location: Glasgow ATZ

PART A: SUMMARY OF INFORMATION REPORTED TO UKAB

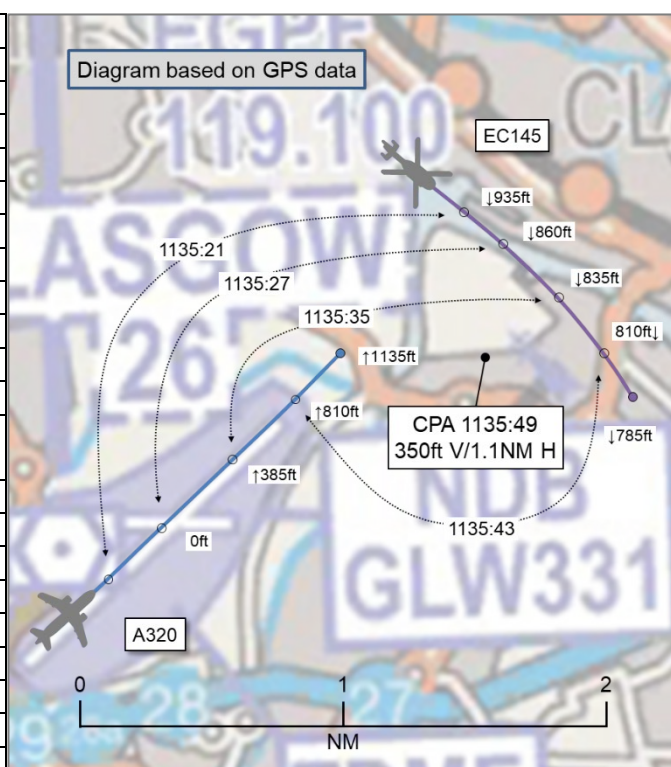
Recorded	Aircraft 1	Aircraft 2
Aircraft	A320	EC145
Operator	CAT	HEMS
Airspace	Glasgow CTR	Glasgow CTR
Class	D	D
Rules	IFR	VFR
Service	ACS	ACS
Provider	Glasgow Tower	Glasgow Tower
Altitude/FL	1135ft	785ft
Transponder	A, C, S+	A, C, S
Reported		
Colours	White, Orange	Yellow
Lighting	Nav, Strobes, Landing	Nav, Landing, Anti-Cols
Conditions	VMC	VMC
Visibility	>10km	>10km
Altitude/FL	1300ft	'Descending'
Altimeter	QNH (NK hPa)	QNH (NK hPa)
Heading	048°	'Southeasterly'
Speed	150kt	130kt
ACAS/TAS	TCAS II	TCAS I
Alert	None	None
Separation at CPA		
Reported	300ft V/0.5-1NM H	NK V/NK H
Recorded	350ft V/1.1NM H

THE A320 PILOT reports that it's common practice for ATC to inform them of ambulance helicopter traffic on the climb-out. They were on a tight slot, holding at G2 for RW05. Line-up and take-off clearance was issued for RW05 and, as they commenced the take-off roll, ATC called at around 50kts about a helicopter in the climb-out. The call was acknowledged and take-off continued. As they rotated the helicopter was straight ahead, passing left-to-right at around 1000ft, approximately 1.5NM ahead. Take-off pitch was maintained and they passed about 300ft above the helicopter with it 0.5-1NM to their right-hand side. They were visual with the helicopter the entire time and no TCAS RA was issued, although RAs are inhibited below 1000ft.

THE GLASGOW TOWER OJTI reports that they were working in AIR, monitoring a controller who was returning from a period off work. The traffic loading was medium-heavy with ILS calibration in progress. [The EC145 pilot] had been cleared through the RW05 climb-out, [the A320 had] lined-up and a G115 was on base. The controller-being-monitored then cleared [the A320 pilot] for take-off before [the EC145] had crossed through the centreline. They pointed out to the controller that [the A320 pilot] had not yet had Traffic Information on [the EC145], this the controller did straight away as [the A320 pilot] was commencing their take-off roll. At no point did they consider there a need to stop [the A320] or orbit [the EC145], they had them both in sight and [the EC145] was through the centreline a matter of seconds later and [the A320] then passed behind and above it.
