AIRPROX REPORT No 2022258

Date: 02 Nov 2022 Time: 0941Z Position: 5303N 00029W Location: RAF Cranwell

PART A: SUMMARY OF INFORMATION REPORTED TO UKAB

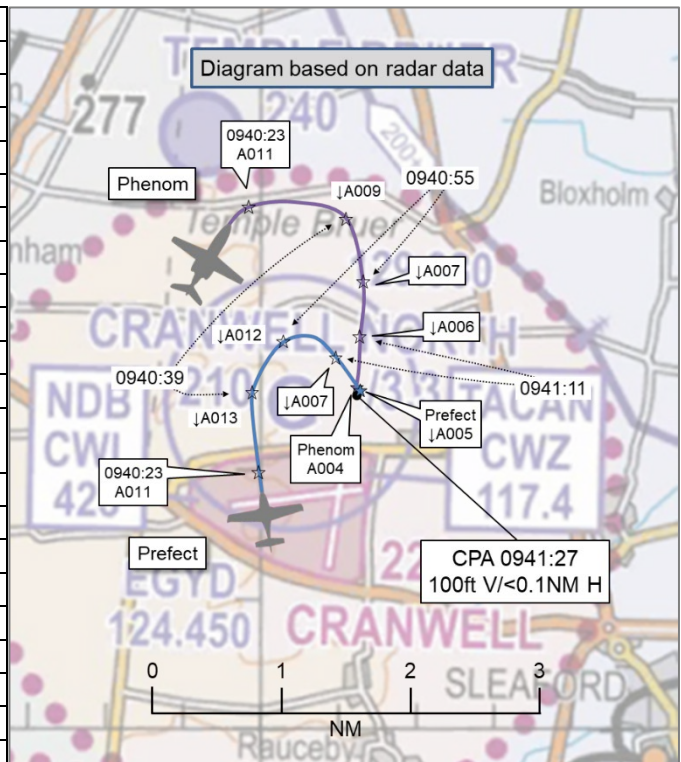
Recorded	Aircraft 1	Aircraft 2
Aircraft	Prefect	Phenom
Operator	HQ Air (Trg)	HQ Air (Trg)
Airspace	Cranwell CMATZ	Cranwell CMATZ
Class	G	G
Rules	VFR	VFR
Service	ACS	ACS
Provider	Cranwell Tower	Cranwell Tower
Altitude/FL	500ft	400ft
Transponder	A, C, S	A, C, S+
Reported		
Colours	White	Blue, White
Lighting	Nav, Strobes, Landing	NR
Conditions	VMC	VMC
Visibility	>10km	>10km
Altitude/FL	NR	400ft
Altimeter	NR	QFE (1006hPa)
Heading	360°	188°
Speed	NR	115kt
ACAS/TAS	TAS	TCAS I
Alert	Information	None
Separation at CPA		
Reported	150ft V/150ft H	100ft V/50m H
Recorded	100ft V/<0.1NM H
