**AIRPROX REPORT No 2023009**

Date: 29 Jan 2023 Time: 0947Z Position: 5414N 00114W Location: 1NM W Sutton Bank

**PART A: SUMMARY OF INFORMATION REPORTED TO UKAB**

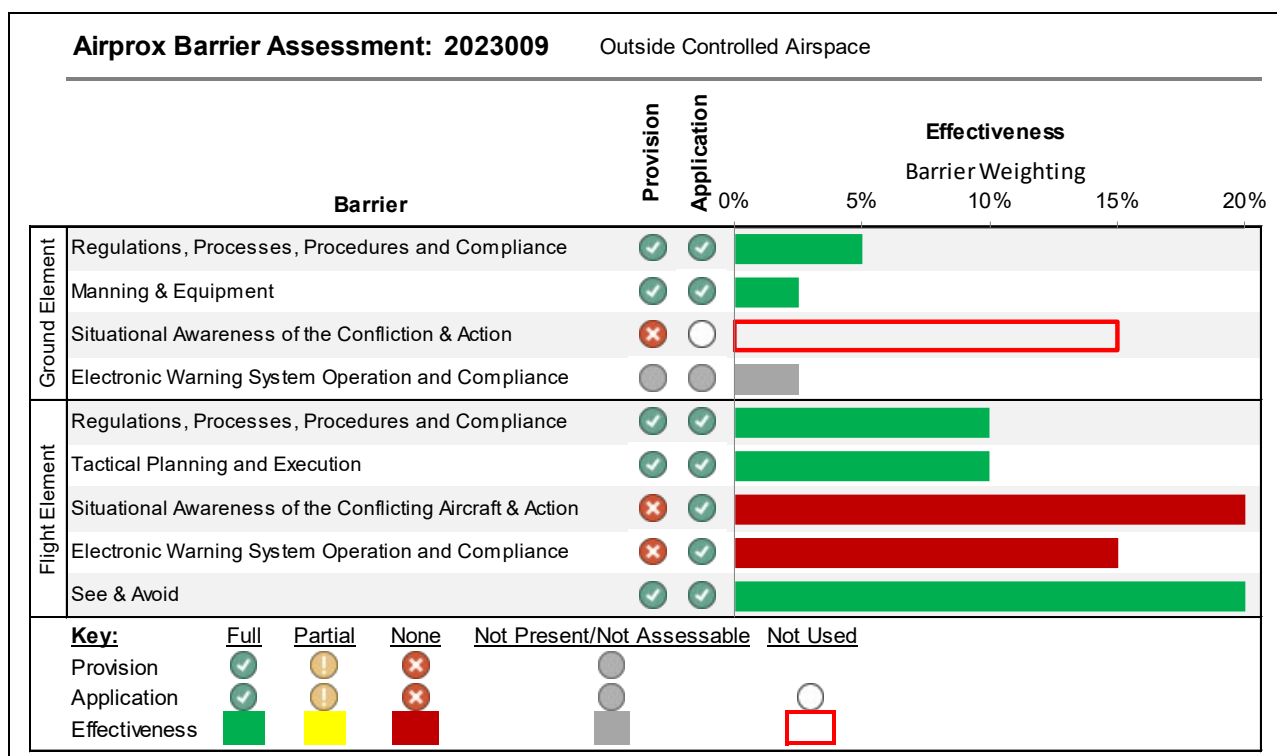
**Situational Awareness of the Conflicting Aircraft and Action** were assessed as **ineffective** because the pilot of the ASK21 had not had situational awareness of the presence of the PA28.

**Electronic Warning System Operation and Compliance** were assessed as **ineffective** because the EC equipment fitted to the ASK21 would not have been expected to have detected the presence of the PA28.
