## AIRPROX REPORT No 2023013

Date: 12 Feb 2023 Time: 1351Z Position: 5215N 00253W Location: Shobdon ATZ

### PART A: SUMMARY OF INFORMATION REPORTED TO UKAB

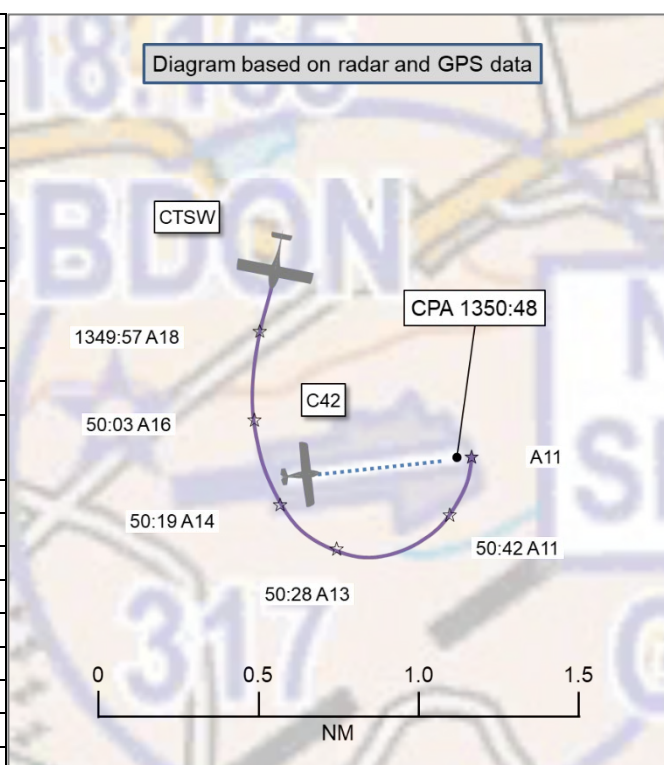
**THE C42 INSTRUCTOR** reports flying with a pre-solo student on a circuit detail, flying right-hand, 500ft microlight circuits from RW08. On climb-out at 400ft, the Instructor noticed a CTSW immediately ahead, tracking right-to-left. The CTSW was entering the deadside at approximately 1000ft, 500ft below the minimum 1500ft dead side limit. The C42 Instructor turned right onto crosswind and called on the radio to announce they had seen a CTSW entering the dead side at 1000ft. They were concerned that the CTSW would come in to conflict with gliders, active that day, on downwind left-hand (on the deadside). As they tuned downwind right-hand for RW08, they continued to look out for the CTSW, concerned they might conflict again. The CTSW had commenced a left-hand 1000ft circuit on the deadside but then repositioned above and ahead of them on the right-hand microlight circuit for RW08. Once again, they announced that they could see the CTSW above in the microlight circuit and questioned its pilot's intentions. At that point the CTSW pilot climbed and moved out towards the corner of the downwind and base-leg on the GA circuit. The C42 Instructor carried out their circuit detail with no further conflict. After landing they went to see the FISO who said they did not see the conflict but were aware of the C42 Instructor's R/T calls. The C42 Instructor said they would file an Airprox. They went to see the pilot of the CTSW in the airfield cafe and introduced themselves. The CTSW pilot recognised there had been a problem, but partly blamed the FISO for giving them misleading information. They claimed the FISO had told them the circuits were 08 left-hand. The CTSW pilot then claimed they saw the C42 on climb-out but then couldn't see them behind them because they didn't appear on their [TAS]. They said the [TAS] wasn't set up for audible alerts, instead they had to look at the screen for traffic information. The C42 Instructor explained that they were flying right-hand circuits, that their aircraft was not fitted with a transponder, like many aircraft in the circuit, and that the CTSW pilot should refrain from looking at the [TAS] screen in the circuit. They tried to explain the circuit patterns and restrictions for GA, microlights and gliders at Shobdon, but the CTSW pilot said he knew the procedures and had flown here many times before. The C42 Instructor shook his hand and wished him a safe flight home.

**THE CTSW PILOT** reports that they decided to fly to Shobdon. It appeared that the C42 was doing short circuits and touch-and-goes. They did not see the C42 and, on reaching the base leg of the wide circuit, the C42 was landing on RW08. They received no radio communication from the C42 pilot and later found out that the C42 had no transponder or other identification so was not picked up by their TAS. They had seen the C42 doing a touch-and-go on RW08 and had only the Instructor's word that there had been an Airprox. In retrospect a better action would have been to follow the C42 going outside its track and then go to the wider circuit, thus avoiding any possibility of conflict.

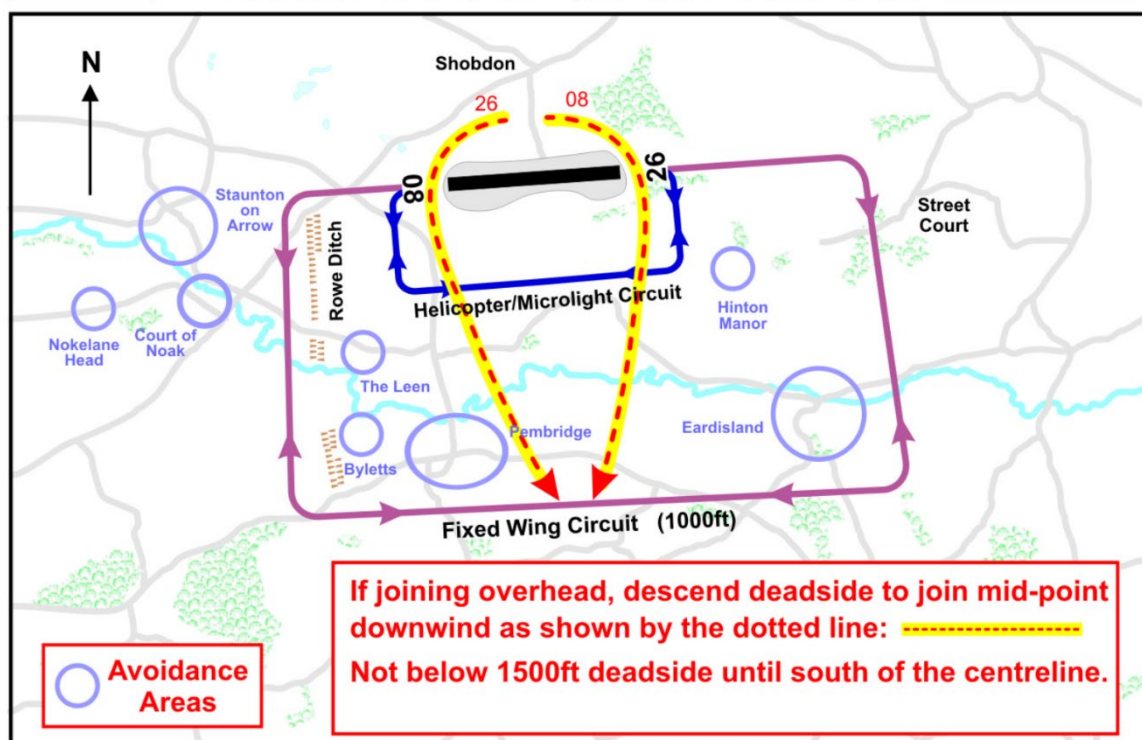
# SHOBDON AIRFIELD NOISE ABATEMENT AREAS

It cannot be determined if the pilot of the CTSW had correctly briefed for a right-hand circuit, but having incorrectly read back left-hand they appeared to position for a circuit to the north. Had the wrong readback been detected on either of the first two occasions by the FISO, it is considered likely that the pilot of the CTSW would have been able to reposition in good time and still remain ahead of the C42 joining the circuit behind them.
