## AIRPROX REPORT No 2023026

Date: 28 Feb 2023 Time: 1420Z Position: 5321N 00339W Location: 3.5NM NE Colwyn Bay

### PART A: SUMMARY OF INFORMATION REPORTED TO UKAB

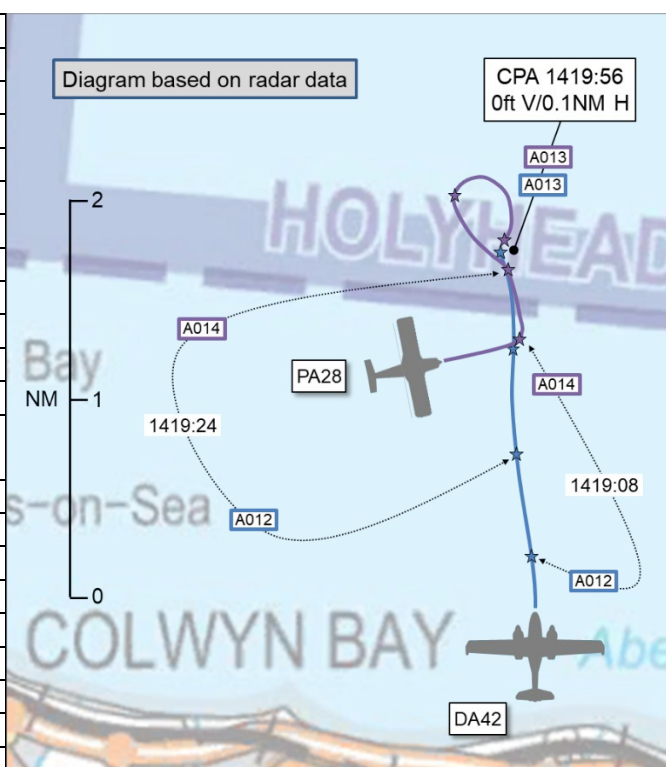
Recorded	Aircraft 1	Aircraft 2
Aircraft	DA42	PA28
Operator	Civ Comm	Civ FW
Airspace	London FIR	London FIR
Class	G	G
Rules	VFR	VFR
Service	None	Listening Out
Provider	N/A	Liverpool Radar
Altitude/FL	1300ft	1300ft
Transponder	A, C, S+	A, C, S
Reported		
Colours	White	White, orange
Lighting	Landing, taxi, nav, strobes	Landing
Conditions	VMC	VMC
Visibility	>10km	>10km
Altitude/FL	1800ft	1500ft
Altimeter	QNH (NK hPa)	QNH (NK hPa)
Heading	360°	NK
Speed	130kt	95kt
ACAS/TAS	TAS	Not fitted
Alert	TA	N/A
Separation at CPA		
Reported	0ft V/0.2NM H	500ft V/2NM H
Recorded	0ft V/0.1NM H

An analysis of the NATS radar replay was undertaken. Both aircraft could be positively identified from Mode S data. At 1418, the DA42 was observed to be south of the coastline and tracking to the west. The PA28 was observed to be broadly north of the coastline, tracking to the east. The pilot of the DA42 then turned northwards and crossed the coastline. At 1419, the pilot of the PA28 also turned northwards, directly ahead of the DA42 by approximately 1NM. It had been after the pilot of the PA28 had commenced a steep turn to the right that the CPA occurred (see Figure 1). The separation at CPA was determined, and the diagram constructed, from the radar data.
