AIRPROX REPORT No 2023024

Date: 23 Feb 2023 Time: 1533Z Position: 5411N 00128W Location: 3NM W Topcliffe

PART A: SUMMARY OF INFORMATION REPORTED TO UKAB

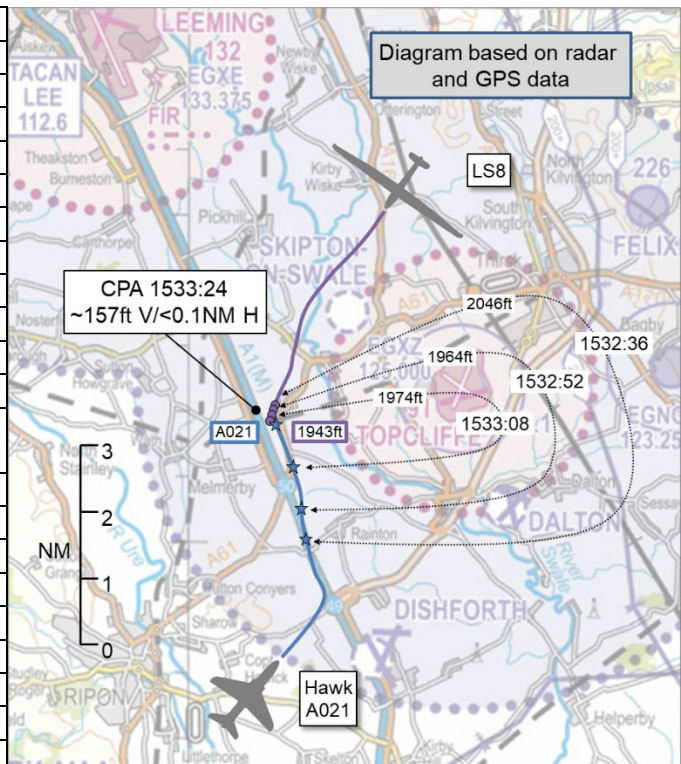
Recorded	Aircraft 1	Aircraft 2
Aircraft	Hawk	LS8
Operator	Foreign Mil	Civ Gl'd
Airspace	Leeming CMATZ	Leeming CMATZ
Class	G	G
Rules	VFR	VFR
Service	Traffic	None
Provider	Leeming Radar	N/A
Altitude/FL	2100ft	1943ft
Transponder	A, C, S	Not fitted
Reported		
Colours	Black	White
Lighting	White Strobes, Nav lights	None
Conditions	VMC	VMC
Visibility	>10km	>10km
Altitude/FL	2000ft	1800ft
Altimeter	QFE (1015hPa)	QNH (NK hPa)
Heading	335°	200°
Speed	165kt	55kt
ACAS/TAS	Unknown	FLARM
Alert	TA ¹	None
Separation at CPA		
Reported	"400ft"	0ft V/75m H
Recorded	~157ft V/<0.1NM H

The CPA was unmeasured as the glider was not observed on the NATS radar. The CPA reported by the Hawk pilot was 400ft and 0.3NM.

An analysis of the NATS radar replay was undertaken and the Hawk could be positively identified from Mode S data (see Figure 3). An appropriate conversion factor was applied to the Flight Level observed on radar to convert it to an altitude. The LS8 was observed on radar a few minutes before CPA but the returns faded and the LS8 was not observed at the time of CPA. The pilot of the LS8 kindly supplied GPS track data for their flight. It was by combining the GPS and radar data that the diagram was constructed and the separation at CPA determined.
