**AIRPROX REPORT No 2023034**

Date: 27 Mar 2023 Time: 1313Z Position: 5247N 00018W Location: 4.5NM W Spalding

**PART A: SUMMARY OF INFORMATION REPORTED TO UKAB**

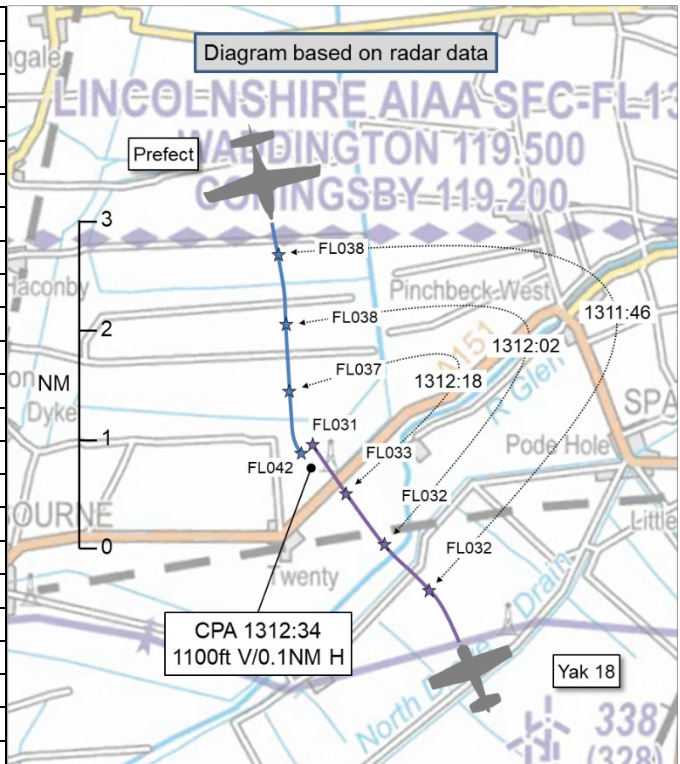
Recorded	Aircraft 1	Aircraft 2
Aircraft	Prefect	Yak 18
Operator	HQ Air (Trg)	Civ FW
Airspace	London FIR	London FIR
Class	G	G
Rules	VFR	VFR
Service	Traffic	Basic
Provider	Cranwell Departure	Waddington
Altitude/FL	FL042	FL031
Transponder	A, C, S	A, C, S
<b>Reported</b>		
Colours	White, blue	Blue
Lighting	HISL, nav, landing	Beacon
Conditions	VMC	VMC
Visibility	>10km	>10km
Altitude/FL	4000ft	3300ft
Altimeter	RPS (1021hPa)	QNH (NK hPa)
Heading	180°	130°
Speed	140kt	130kt
ACAS/TAS	TAS	Not fitted
Alert	Information	N/A
<b>Separation at CPA</b>		
Reported	200ft V/0ft H	1000ft V/NR NM H
Recorded	1100ft V/0.1NM H
