AIRPROX REPORT No 2023030

Date: 14 Mar 2023 Time: 1145Z Position: 5202N 00237W Location: 3.5NM SE Hereford

PART A: SUMMARY OF INFORMATION REPORTED TO UKAB

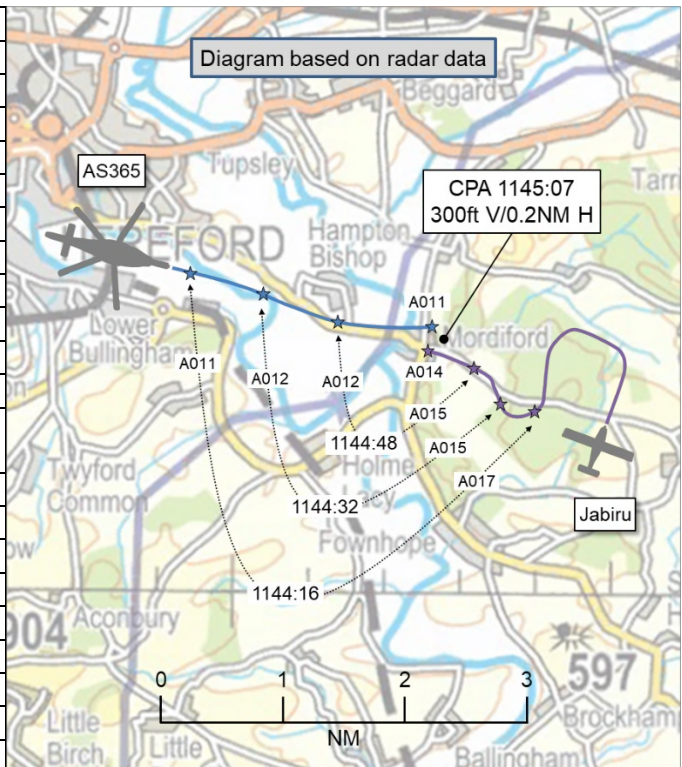
Recorded	Aircraft 1	Aircraft 2
Aircraft	AS365	Jabiru
Operator	HQ JHC	Civ FW
Airspace	London FIR	London FIR
Class	G	G
Rules	VFR	VFR
Service	Basic	Listening Out
Provider	Gloster Approach	Shobdon Radio
Altitude/FL	1100ft	1300ft
Transponder	A, C	A, C
Reported		
Colours	Dark blue, white	White
Lighting	Nav, anti-col, strobe	Nose light
Conditions	VMC	VMC
Visibility	>10km	>10km
Altitude/FL	1500ft	1700ft
Altimeter	QNH (1008hPa)	QNH (NK hPa)
Heading	120°	NK
Speed	130kt	90kt
ACAS/TAS	Other	Not fitted
Alert	TA	None
Separation at CPA		
Reported	100ft V/0.1NM H	200ft V/0.5NM H
Recorded	300ft V/0.2NM H
