AIRPROX REPORT No 2023027

Date: 02 Mar 2023 Time: 1510Z Position: 5110N 00145W Location: Boscombe Down

PART A: SUMMARY OF INFORMATION REPORTED TO UKAB

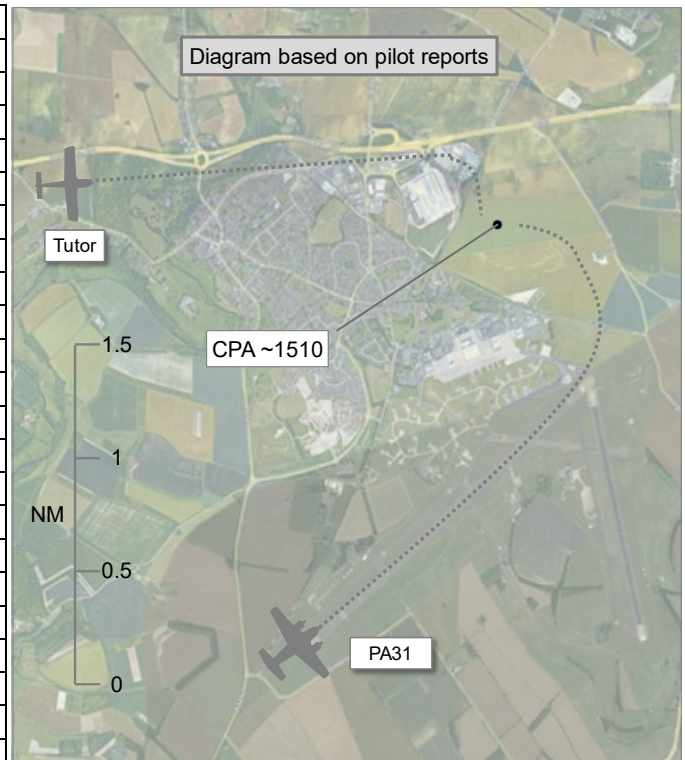
THE TUTOR PILOT reports that, despite having 3 hours of endurance fuel available and flying in CAVOK conditions, Boscombe Down Approach ordered the 4 airborne Tutors on their frequency to recover to base due to the electrical power problems they were encountering. The aircraft were asked to stagger their recoveries and they [the Tutor pilot] were the third to enter the 'north lane'. On contacting Boscombe Tower they were given the information that there were 2 aircraft in the northern circuit (800ft light-aircraft circuit) and these were the 2 Tutors that had just recovered ahead of them. As they approached Stonehenge they requested an update on the position of the traffic in the northern circuit and were told that one Tutor had just landed on the north runway and the other Tutor was downwind. They therefore elected to do a standard join to RW05 north of Amesbury to the warehouses on Solstice Park "Bulford" and then a right turn onto downwind and gain visual contact with the Tutor downwind. Satisfied that they had sufficient spacing behind the Tutor ahead, they started the right-hand turn and called "Bulford" on the radio. At that point, they were surprised and alarmed to see another aircraft in front of them climbing through their height. They immediately requested an update on the circuit traffic in the northern circuit and were again told about the Tutor that had landed and the one ahead, now turning final. They then asked ATC to clarify what the twin-engine aircraft that had crossed ahead of them and climbed through their level was doing and were told it was a [Boscombe] callsign departing the airfield. The radios were busy but they had not heard this callsign call for take-off whilst they were on the frequency. They had also wrongly presumed that because all of the Tutors had been ordered to return to base that departures would not be authorised but, notwithstanding that, departing aircraft should not have been climbing through 800ft and conflicting with traffic downwind in the circuit pattern. The pilot opined that had they turned downwind slightly earlier they believed they may have been unsighted on this aircraft and there would have been a very real danger of collision, both aircraft being belly-up to each other at 800ft in the same piece of sky, and that there is also a possibility that this aircraft passed through the avoid set-up around the shooting range at Beacon Hill which should not be overflown below 1000ft. They landed without further incident and, from speaking to ATC after landing,

THE PA31 PILOT reports that the clearance was to depart left turnout downwind RW05, VFR west 4000ft. They reported ready for immediate departure, however, with a light-aircraft at 7NM, they were told to hold. A 20min delay at the hold then ensued as multiple aircraft commenced recovery to the airfield to a variety of runways, with multiple helicopters in the hover. ATC seemed to be working hard, and them [the PA31 pilot] being on VHF may have caused an increase in their [ATC] workload. "Mass Recovery" and "Power Failure" were mentioned. On the ground, distorted VHF from some aircraft and unfamiliar reporting points/joining procedures degraded their situational awareness (SA). Shortly before departure, the clearance was amended to 2000ft and the autopilot altitude warner was set. Take-off clearance was eventually given with no conflicting Traffic Information passed. The aircraft was hand-flown due to the proximity of danger areas and the approach lane. As they turned left downwind, TAS displayed 2 contacts at a similar level and relatively close range, probably <2NM, to the north and west respectively. At this point, with degraded SA, they assessed they were higher and visual with the northern traffic, and could climb clear of the western traffic. The pilot opined that they did feel that they should have done a better job of building their SA on the ground, despite the difficulties in comms, unfamiliar light-aircraft joins from the north, and lack of warning from ATC. They were not expecting joining aircraft to be approaching the circuit from the north as they turned downwind to follow their clearance.

As a result of a Station mains power failure, the 4 Boscombe Down Tutors operating in the local area were instructed to recover. At the point that the PA31 pilot reported ready for departure, the Boscombe Down Tower controller was providing an Aerodrome Service to a Merlin operating southside, 2 Tutors established within the northern circuit (800ft), both to land, and a third Tutor on recovery.

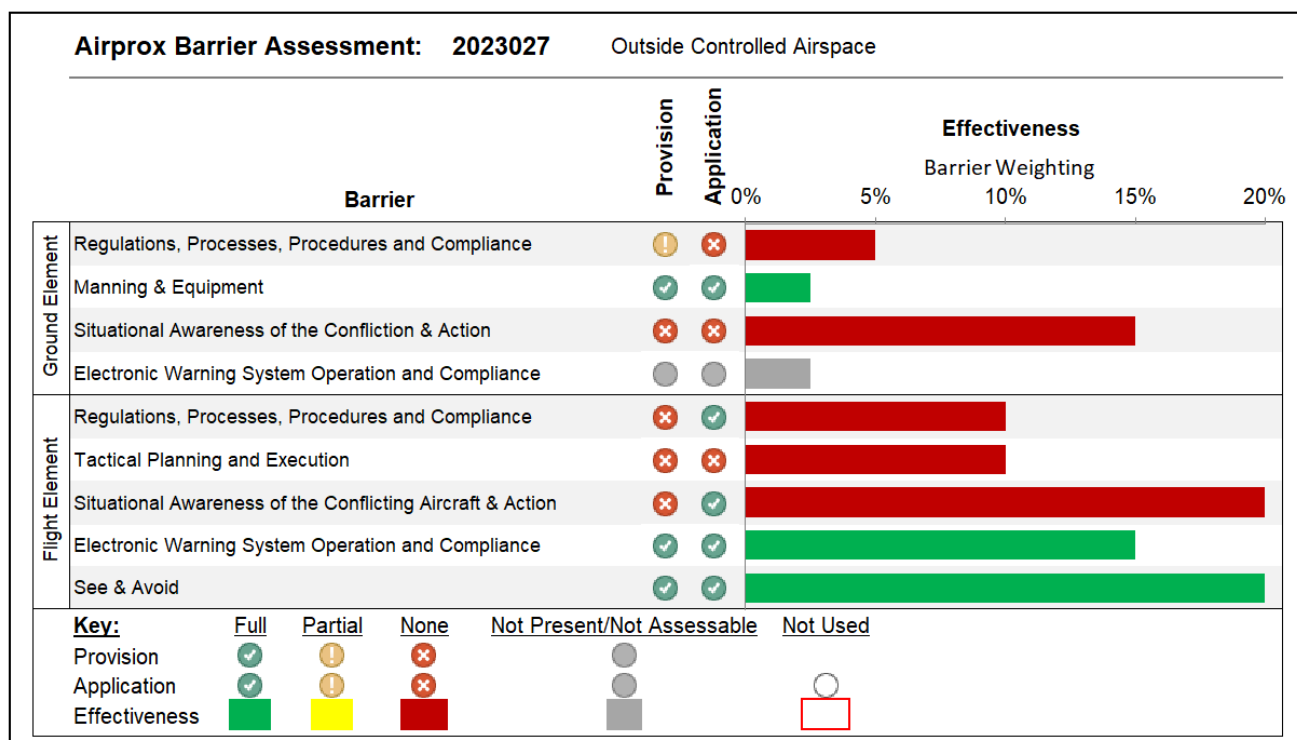
Tactical Planning and Execution was assessed as **ineffective** because the local departure procedures were not available to the PA31 pilot.

Situational Awareness of the Conflicting Aircraft and Action were assessed as **ineffective** because the Tutor pilot had no awareness of the presence of the PA31 and the PA31 pilot had not been informed of the Tutor’s presence in the northern circuit.
