AIRPROX REPORT No 2023032

Date: 15 Mar 2023 Time: 1137Z Position: 5204N 00108W Location: Turweston

PART A: SUMMARY OF INFORMATION REPORTED TO UKAB

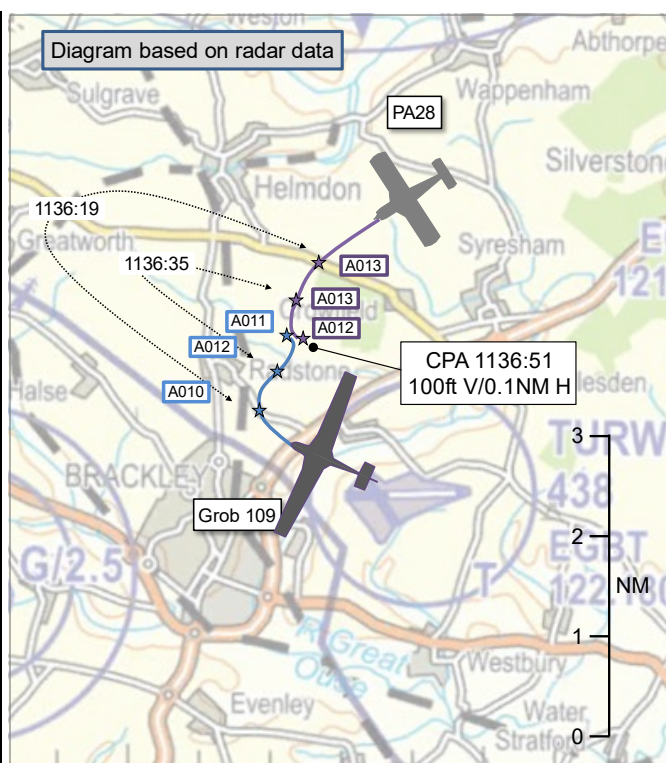
| Recorded | Aircraft 1 | Aircraft 2 |
|---|---|---|
| Separation at CPA | | |
| Reported | 0ft V/50m H | Not Seen |
| Recorded | 100ft V/0.1NM H | |
