AIRPROX REPORT No 2023059

Date: 17 Apr 2023 Time: 1737Z Position: 5213N 00049E Location: 3NM SE Rougham

PART A: SUMMARY OF INFORMATION REPORTED TO UKAB

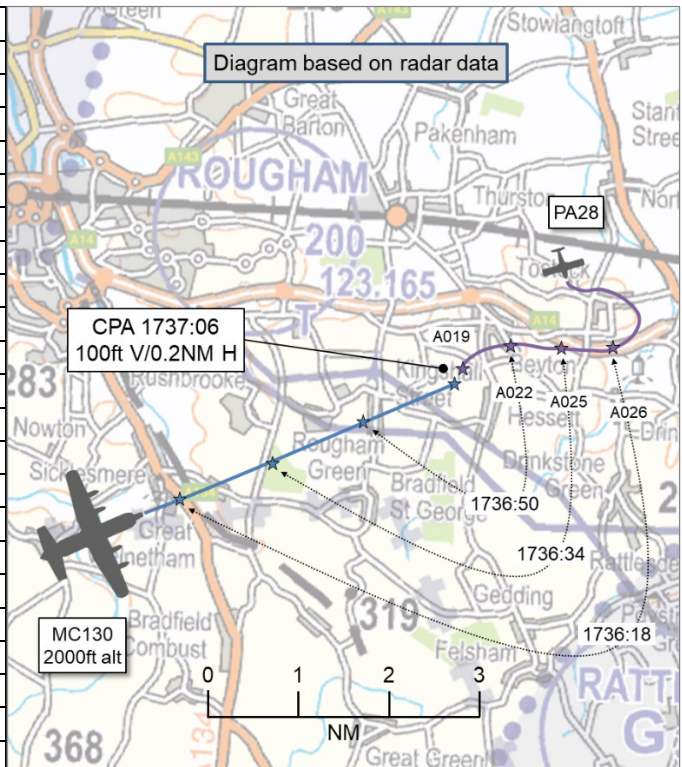
Recorded	Aircraft 1	Aircraft 2
Aircraft	MC130	PA28
Operator	Foreign Mil	Civ FW
Airspace	London FIR	London FIR
Class	G	G
Rules	VFR	VFR
Service	Traffic	Listening Out
Provider	Lakenheath Radar	Rougham Radio
Altitude/FL	2000ft	1900ft
Transponder	A, C	A, C
Reported		
Colours	Grey	Red, white
Lighting	Nav	Strobes, beacon
Conditions	VMC	VMC
Visibility	>10km	>10km
Altitude/FL	2000ft	2000ft
Altimeter	QNH (NK hPa)	QNH (NK hPa)
Heading	066°	260°
Speed	NK	105kt
ACAS/TAS	TCAS II	SkyEcho
Alert	None	None
Separation at CPA		
Reported	300ft V/0NM H	350ft V/0.75NM H
Recorded	100ft V/0.2NM H

An analysis of the NATS radar replay was undertaken. Both aircraft could be identified from their squawks and by reference to each pilot's narrative report. The aircraft were observed on radar to be at Flight Levels and an appropriate conversion factor was used to calculate their respective altitudes. The diagram was constructed and the separation at CPA determined from the radar data.
