AIRPROX REPORT No 2023051

Date: 16 Apr 2023 Time: 1426Z Position: 5150N 00117W Location: Oxford ATZ

PART A: SUMMARY OF INFORMATION REPORTED TO UKAB

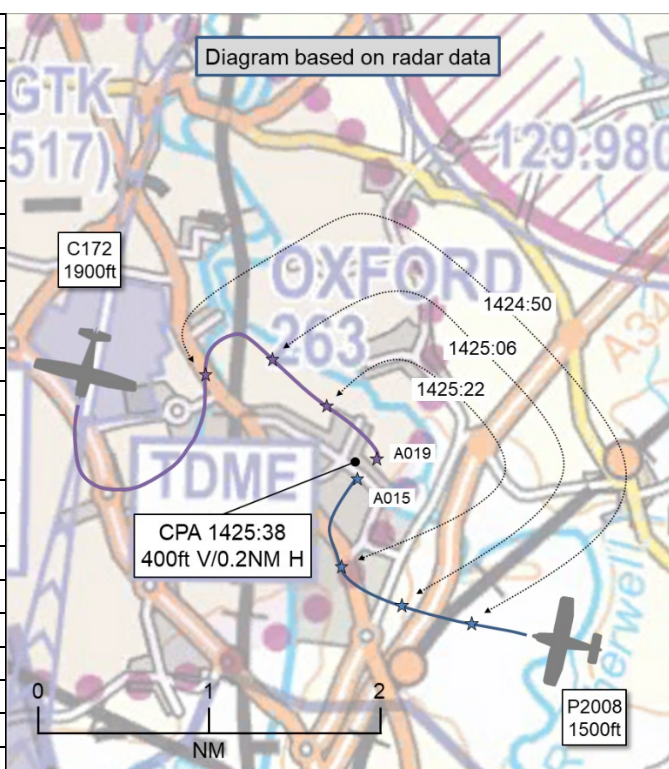
Recorded	Aircraft 1	Aircraft 2
Aircraft	P2008	C172
Operator	Civ FW	Civ FW
Airspace	Oxford ATZ	Oxford ATZ
Class	G	G
Rules	VFR	VFR
Service	ACS	ACS
Provider	Oxford Tower	Oxford Tower
Altitude/FL	1500ft	1900ft
Transponder	A, C, S	A, C, S+
Reported		
Colours	White, grey	White, blue
Lighting	Strobes, landing, taxi, nav	Beacon, nav, strobes, wing lights
Conditions	VMC	VMC
Visibility	5-10km	5-10km
Altitude/FL	1300ft	1800ft
Altimeter	QNH (NR hPa)	QNH (1026hPa)
Heading	010°	225°
Speed	100kt	108kt
ACAS/TAS	Not fitted	Not fitted
Separation at CPA		
Reported	200ft V/0.5NM H	300ft V/0.3NM H
Recorded	400ft V/0.2NM H

THE P2008 PILOT reports that they were joining the left downwind for RW19 from the east of Beckley Mast (5NM east of Oxford). After being transferred to the TWR frequency, they were informed of an aircraft, which was a C172, conducting a low approach for RW19 and departing to the southeast. Whilst descending from 2000ft and joining the downwind for RW19, they levelled-off at a slightly lower altitude, around 1300ft on QNH (by memory). This was lower than the normal 1500ft circuit altitude at Oxford Airport. During this time, they recall ATC giving Traffic Information about [the P2008] to the [pilot of the] other aircraft [C172 callsign] twice, however, ATC didn't receive a response [they recall]. After a while, ATC queried the [pilot of the C172] about their intentions and received a response that they were turning southbound for Compton VOR. At this time, [the pilot of the P2008] was performing downwind checks when they suddenly spotted the C172 crossing from their left-to-right in a hard right turn approaching in an almost opposite direction to [the P2008] on downwind, at approximately 100-200ft above (judged by sight). [The pilot of the P2008] initiated a quick descent to keep clear, and did a slight left turn before continuing downwind. At this point, they reported left-downwind to Oxford Tower and told them they were visual with the aircraft flying the opposite direction above. At this time, they also mentioned to ATC that this was a 'close call'. After switching the other aircraft to Oxford Radar, the Tower controller came back to [the pilot of the P2008] and said [that they] had been visual with both aircraft and were happy with the separation. The subsequent approach and landing were uneventful and the flight came to an end.
