AIRPROX REPORT No 2023042

Date: 07 Apr 2023 Time: 1123Z Position: 5317N 00053W Location: 2.5NM E Gamston

PART A: SUMMARY OF INFORMATION REPORTED TO UKAB

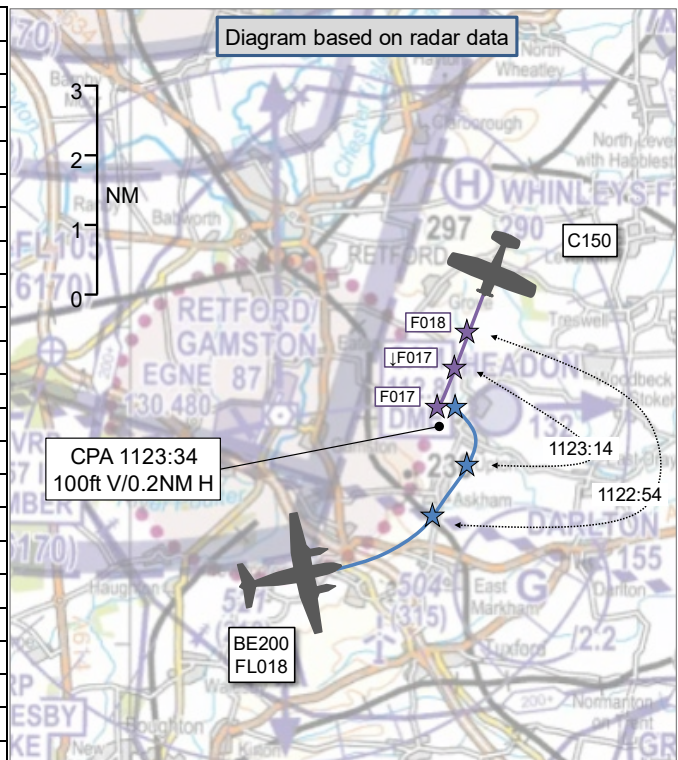
THE BE200 PILOT reports that the 3 green lights for gear were not illuminated, so the pilot initiated a go-around and went to the south of the ATZ climbing to 2000ft. After a left turn and descending deadside for the 02LH circuit when turning level, an aircraft was spotted at similar altitude, crossing east-west through the ATZ at 1800ft, before leaving the ATZ to the west [they believed]. The BE200 pilot took evasive action, turning right to avoid the other aircraft. A normal circuit was performed leading to a normal landing.

THE C150 PILOT reports that they were returning to Gamston from the north. They were proceeding on a heading of 200°, waiting to turn right to cross RW02 on the deadside. They noticed a twin-engine aircraft approaching in the opposite direction and the twin was on course to pass to their left-hand side. They had good sight of the other aircraft for 5-10sec and turned slightly towards the right to gain more horizontal separation. The twin then started to change its heading and fly towards them, but was on course to fly to their rear, just, but closer than they would have liked. The pilot opined that the other pilot clearly hadn't seen them when they [the other pilot] began their turn.

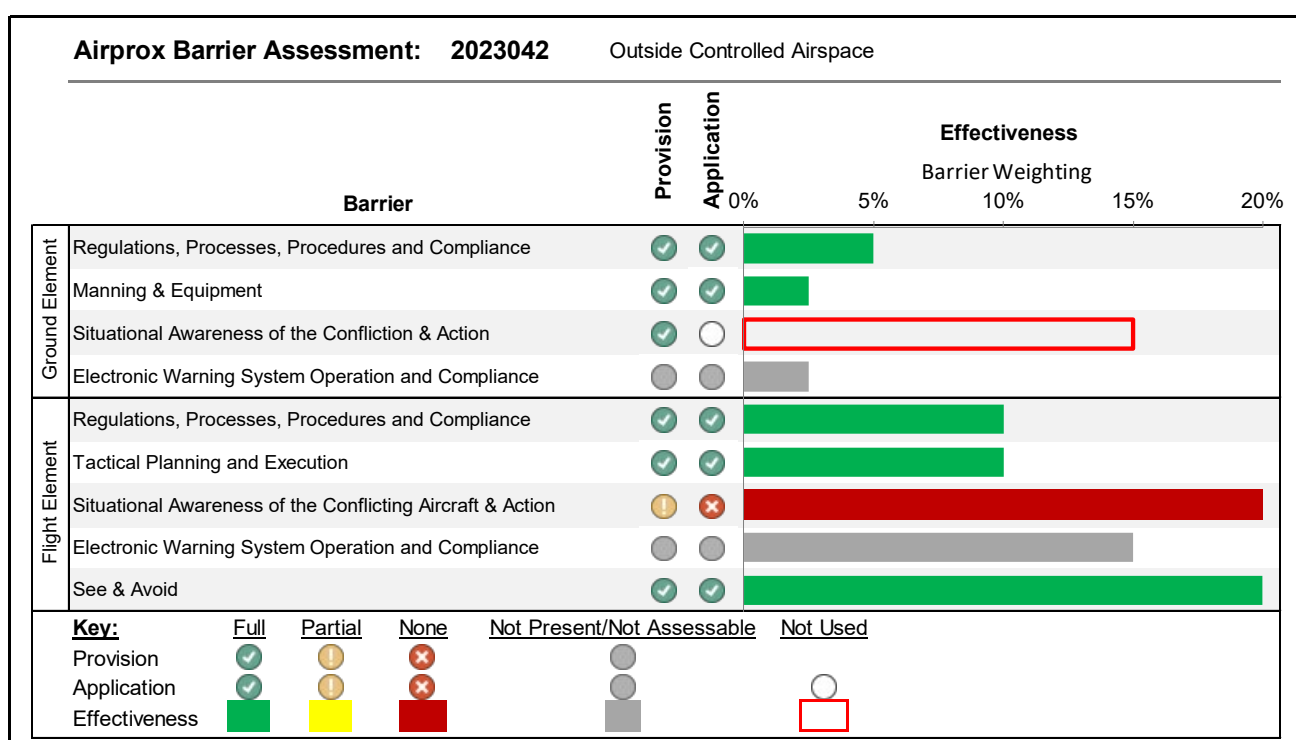
Situational Awareness of the Conflicting Aircraft and Action were assessed as **ineffective** because although both pilots should have been able to garner generic SA from the RT, neither pilot had appeared to assimilate the information that the other had been in the vicinity.
