**AIRPROX REPORT No 2023064**

Date: 01 May 2023 Time: 1311Z Position: 5142N 00049W Location: 1.5NM SE Princes Risborough

**PART A: SUMMARY OF INFORMATION REPORTED TO UKAB**

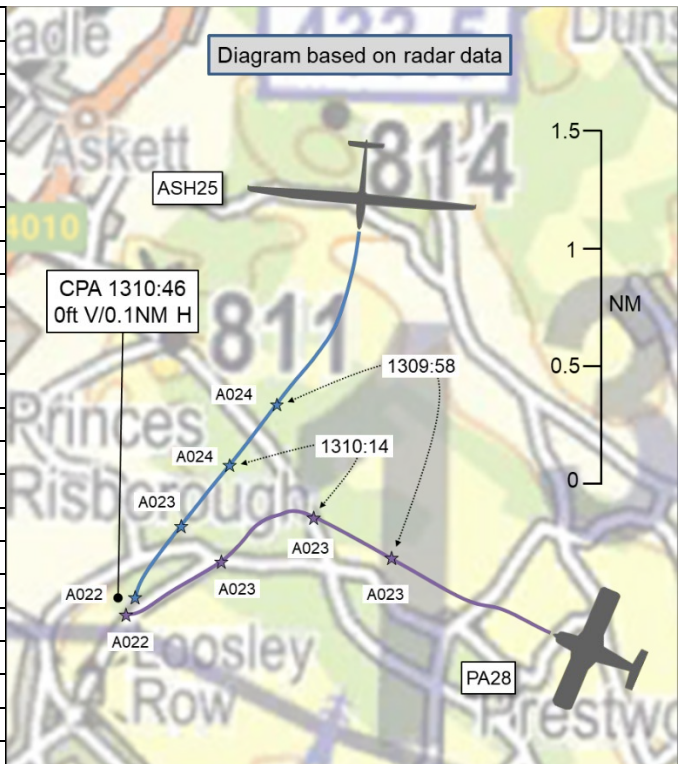
Recorded	Aircraft 1	Aircraft 2
Aircraft	ASH25	PA28
Operator	Civ Gl'd	Civ FW
Airspace	London FIR	London FIR
Class	G	G
Rules	VFR	VFR
Service	None	Basic
Provider	N/A	Farnborough LARS
Altitude/FL	2200ft	2200ft
Transponder	A, C, S	A, C, S
Reported		
Colours	White	White, red, blue
Lighting	None	Beacon, strobes
Conditions	VMC	VMC
Visibility	>10km	>10km
Altitude/FL	2100ft	2300ft
Altimeter	QNH (1018hPa)	QNH (1017hPa)
Heading	230°	270°
Speed	65kt	90kt
ACAS/TAS	PowerFLARM	Not fitted
Alert	None	N/A
Separation at CPA		
Reported	50ft V/70m H	100ft V/0.5NM H
Recorded	0ft V/0.1NM H
