AIRPROX REPORT No 2023071

Date: 12 May 2023 Time: 0938Z Position: 5136N 00117W Location: 1NM West of Didcot

PART A: SUMMARY OF INFORMATION REPORTED TO UKAB

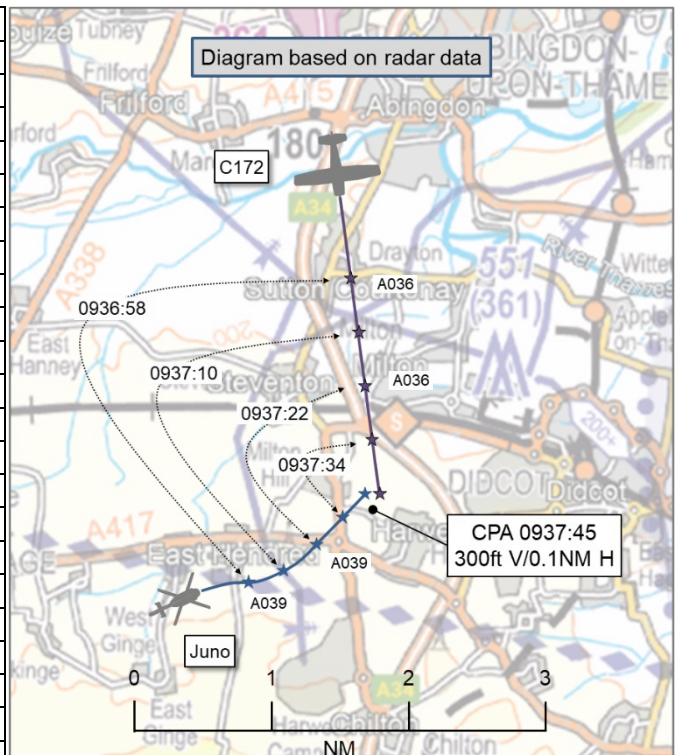
Recorded	Aircraft 1	Aircraft 2
Aircraft	Juno	C172
Operator	HQ Air (Trg)	Civ FW
Airspace	London FIR	London FIR
Class	G	G
Rules	IFR	VFR
Service	Traffic	None
Provider	Benson Approach	N/A ¹
Altitude/FL	3900ft	3600ft
Transponder	A, C, S	A, C
Reported		
Colours	Black and Yellow	White and Brown
Lighting	Strobes/Nav/Landing	Nil
Conditions	IMC	VMC
Visibility	NR	5-10km
Altitude/FL	4000ft	3700ft
Altimeter	QNH (1023hPa)	QNH
Heading	NR	180°
Speed	NR	95kt
ACAS/TAS	TAS	Not fitted
Alert	None	N/A
TCAS Separation at CPA		
Reported	200ft V/0.0NM H	NK V/NK H
Recorded	300ft V/0.1NM H
