AIRPROX REPORT No 2023076

Date: 16 May 2023 Time: 1356Z Position: 5059N 00050E Location: 4NM NW Lydd

PART A: SUMMARY OF INFORMATION REPORTED TO UKAB

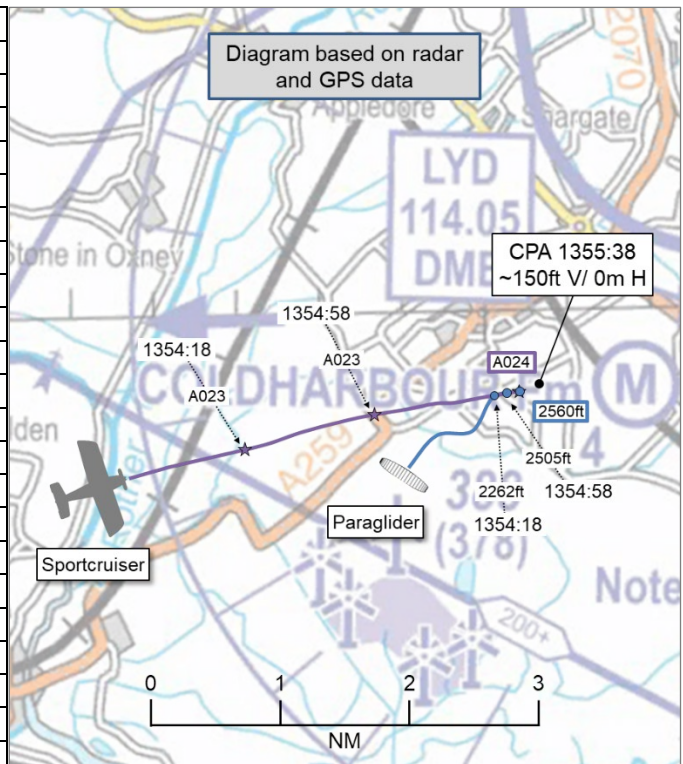
Recorded	Aircraft 1	Aircraft 2
Aircraft	Paraglider	Sportcruiser
Operator	Civ Hang	Civ FW
Airspace	London FIR	London FIR
Class	G	G
Rules	VFR	VFR
Service	None	Basic
Provider	N/A	Lydd Approach
Altitude/FL	2560ft	2400ft
Transponder	Not fitted	A, C, S
Reported		
Colours	Orange, white	Red, white
Lighting	None	Strobes
Conditions	VMC	VMC
Visibility	>10km	NK
Altitude/FL	2280ft	NK
Altimeter	QNH (NK hPa)	QNH
Heading	090°	NK
Speed	20kt	NK
ACAS/TAS	FLARM	None
Alert	None	N/A
Separation at CPA		
Reported	60ft V/0m H	NK V/NK H
Recorded	~150ft V/0m H

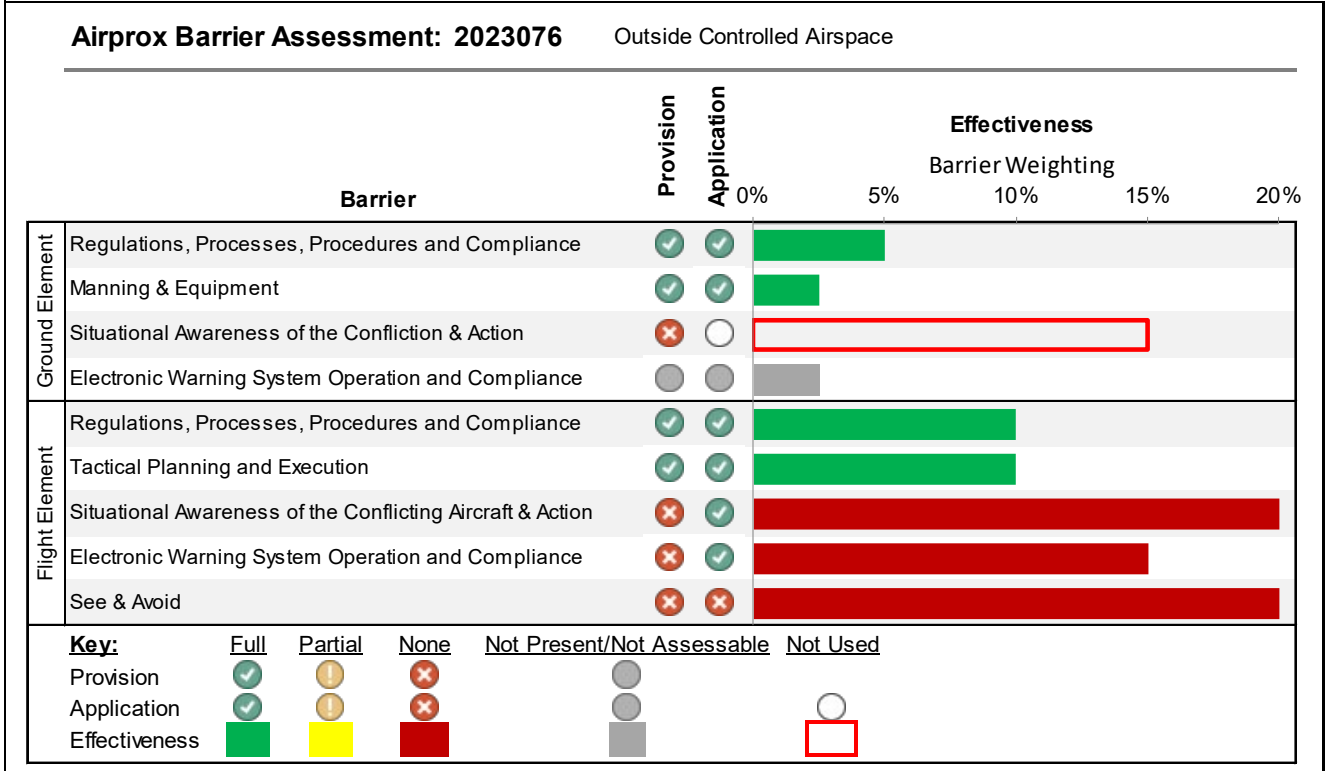
Electronic Warning System Operation and Compliance were assessed as **ineffective** because the EC equipment carried by the paraglider pilot would not have been expected to have detected the presence of the Sportcruiser.

See and Avoid were assessed as **ineffective** because the Sportcruiser pilot had not visually acquired the paraglider, and the paraglider pilot had not visually acquired the Sportcruiser until the moment of CPA.
