AIRPROX REPORT No 2023086

Date: 19 May 2023 Time: 1040Z Position: 5239N 00250W Location: 5NM SW Shrewsbury

PART A: SUMMARY OF INFORMATION REPORTED TO UKAB

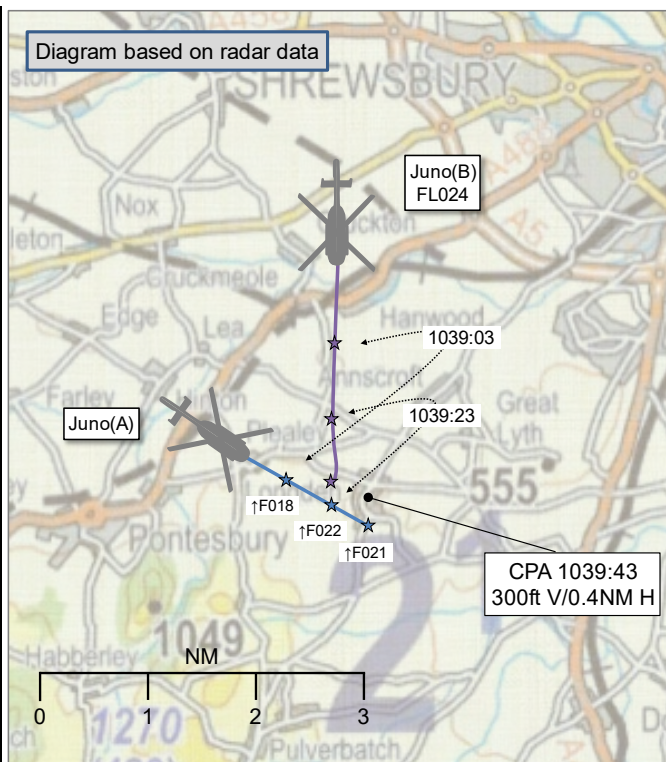
Recorded	Aircraft 1	Aircraft 2
Aircraft	Juno(A)	Juno(B)
Operator	HQ Air (Trg)	HQ Air (Trg)
Airspace	London FIR	London FIR
Class	G	G
Rules	IFR	IFR
Service	Traffic	Traffic
Provider	Shawbury	Shawbury
Altitude/FL	FL021	FL024
Transponder	A, C, S+	A, C, S+
Reported		
Colours	Black, Yellow	Black, Yellow
Lighting	Strobes, HISLs, Position, Landing	NR
Conditions	IMC	IMC
Visibility	<5km	<5km
Altitude/FL	2500ft	2600ft
Altimeter	QFE (1019hPa)	QFE
Heading	120°	180°
Speed	65kt	90kt
ACAS/TAS	TAS	TAS
Alert	None	TA
Separation at CPA		
Reported	300ft V/NK H	Not Seen
Recorded	300ft V/0.4NM H
