AIRPROX REPORT No 2023105

Date: 18 May 2023 Time: 0929Z Position: 5210N 00057W Location: 7NM E of Daventry VOR/DME

PART A: SUMMARY OF INFORMATION REPORTED TO UKAB

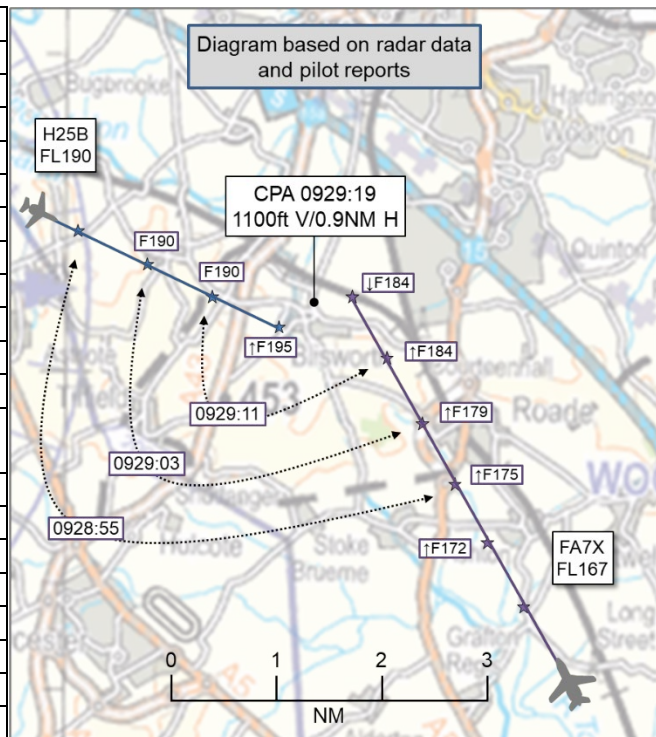
THE NATS CONTROLLER reports that the FA7X had been a London Terminal Manoeuvring Area outbound aircraft heading north. The H25B had been inbound to [destination airfield] via COWLY/WELIN/DAGGA. Both aircraft were on headings. The H25B had been at FL190; the FA7X had been climbed to FL180 underneath. As the FA7X passed approximately FL173 the white STCA alert went off and the controller warned the pilot to maintain FL180 on reaching as there had been traffic 1000ft above their cleared level; no response had been received. Shortly afterwards the controller warned the pilot again and they responded by saying 'TCAS RA'. The controller acknowledged that call.

The controller assumed that the TCAS RA would cause the FA7X to turn away from the H25B but it continued to climb past FL180 and did not look like it had been turning so they issued avoiding action to both aircraft. They turned the FA7X right onto a heading of 025° and the H25B right onto a heading of 185°. Shortly afterwards, [the pilots of] both aircraft reported that they were clear of conflict.
