AIRPROX REPORT No 2023098

Date: 29 May 2023 Time: 1149Z Position: 5348N 00055W Location: Brighton

PART A: SUMMARY OF INFORMATION REPORTED TO UKAB

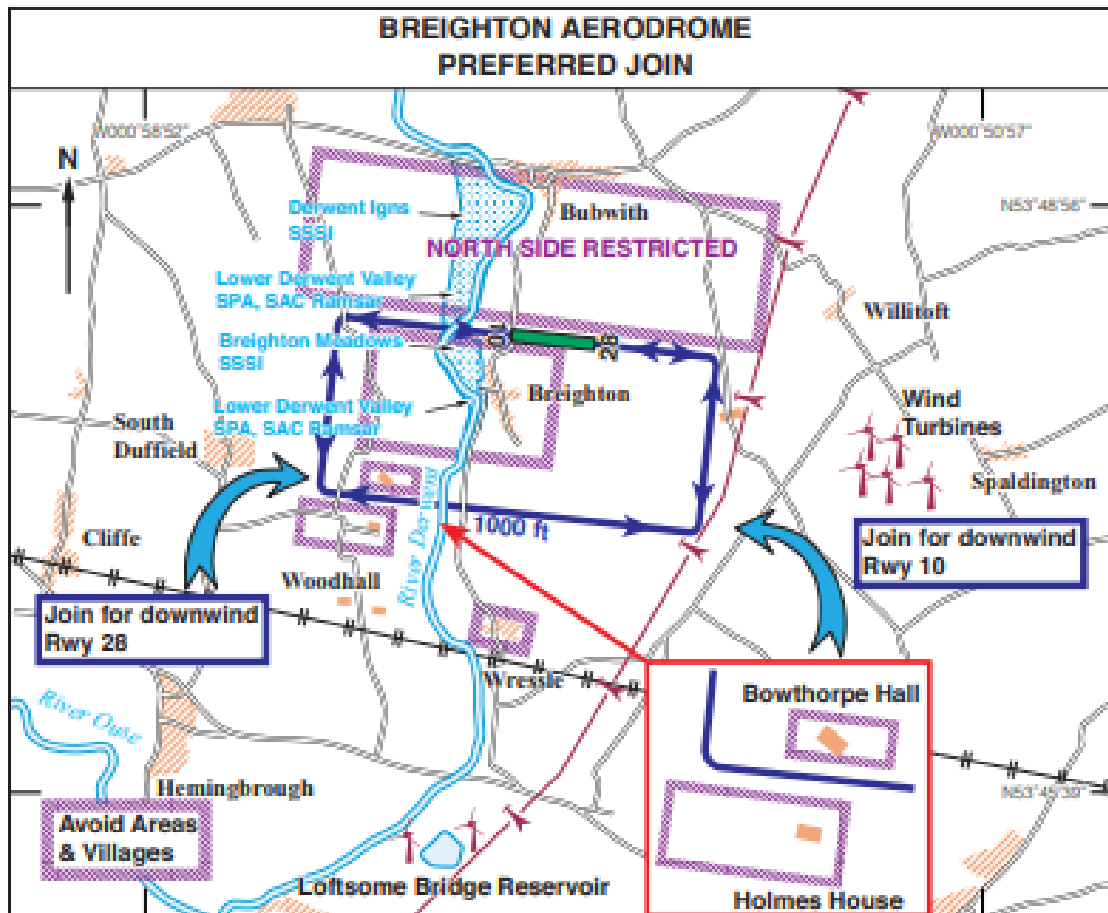
The runway is obscured by buildings and difficult to see from the South.

During special events an additional helicopter parking area in the SW corner of the airfield may be in use.
