**AIRPROX REPORT No 2023101**

Date: 26 May 2023 Time: 1238Z Position: 5258N 00047W Location: 11NM WSW of Cranwell.

**PART A: SUMMARY OF INFORMATION REPORTED TO UKAB**

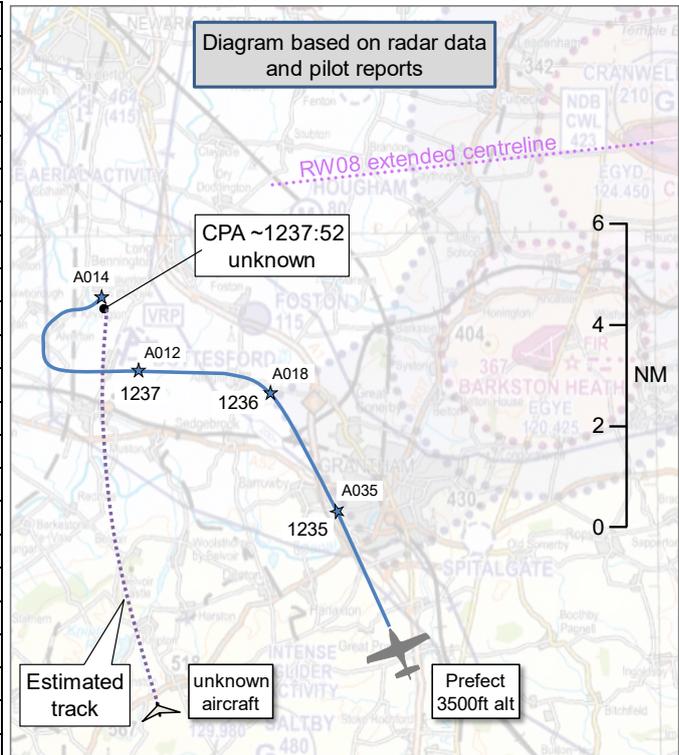
**THE PREFECT PILOT** reports that as staff [instructor] (QFI) they were acting as trainee, flying on instruments and conducting an instrument approach to RW08RH at RAF Cranwell. The [instructor] (QFI) under training was acting as the instructor and was conducting the lookout scan. They were under the control of Cranwell Director, on an intercept heading for a Precision Approach (PAR) of 070°M, level at 1500ft on the Cranwell QFE of 1024 at 140kt, [in visual conditions] below [cloud] and just west of Bottesford disused airfield. The visibility was good but hazy. At about 11NM to Cranwell the non-handling pilot saw a weight-shift microlight about 5° right of their track at a range of about 200m and on a reciprocal track. They took control and flew an emergency break to the left and reported [the incident] as an Airprox to Cranwell. The Cranwell Director confirmed that they did not see other aircraft on radar. There were no TAS or [other traffic alerting devices] indications, they had not seen the microlight again, and the instrument approach was continued without further incident. As captain, they had not seen the microlight at any stage.
