**AIRPROX REPORT No 2023111**

Date: 09 Jun 2023 Time: 1243Z Position: 5130N 00051W Location: 3NM NW of White Waltham

**PART A: SUMMARY OF INFORMATION REPORTED TO UKAB**

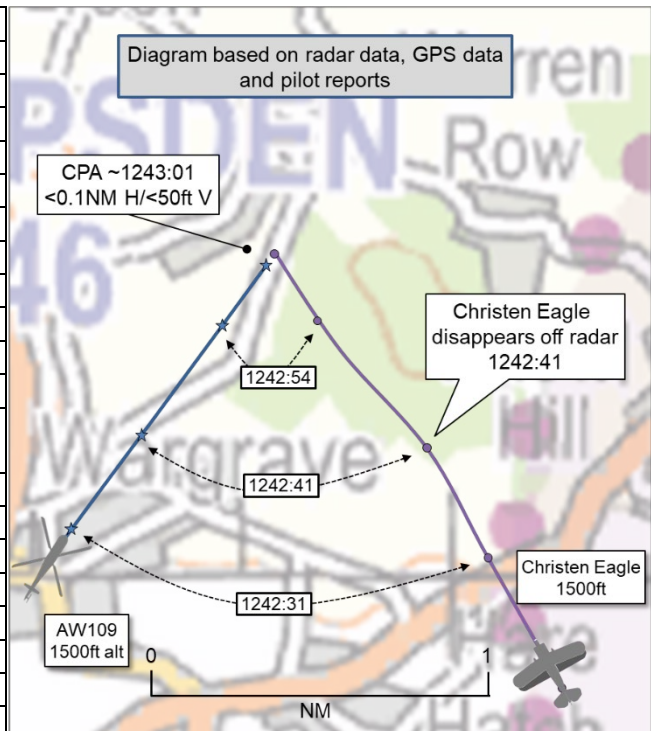
**THE AW109 PILOT** reports that, during the transit under a reduced Traffic Service (due to level), they had seen a biplane climbing out of White Waltham Aerodrome through their level in their 12 o'clock. The aircraft had been close enough to cause concern and they manoeuvred the aircraft to ensure safe separation. ATC did not give warning of the traffic and it did not show on the aircraft TAS or the [EWS equipment]. The AW109 pilot spoke to ATC to ascertain whether they had seen the aircraft but they had not; the AW109 pilot reported the Airprox to them. The other aircraft made no attempt to manoeuvre so they had assumed that they were unaware of the AW109's presence.

On reviewing the tracks into the CPA and the reports of the two pilots, Board members noted that ultimate separation between the aircraft had been minimal. Although difficult to confirm exact separation due to the differing sources, they thought that the Christen Eagle pilot had probably not seen the AW109 (**CF6**) and that avoidance action had been performed by the AW109 pilot alone. Members postulated that perhaps an earlier action on the part of the helicopter pilot might have led to a more comfortable separation, and agreed that, according to the AW109 pilot's report, there had been sufficient time for them to have done so (**CF5**).

When assessing the risk, members considered the reports from both pilots, the radar replay, the GPS data provided by the Christen Eagle pilot and the military investigation report. They noted that the separation between the two aircraft had been much reduced. They also noted that the AW109 pilot described the risk of collision as 'Low', and that although they had initiated avoiding action, members thought that this had not been early enough to comfortably increase the separation and therefore assigned a Risk Category B to this Airprox (**CF7**).
