**AIRPROX REPORT No 2023144**

Date: 29 Jun 2023 Time: 1428Z Position: 5250N 00239W Location: 3NM N Shawbury

**PART A: SUMMARY OF INFORMATION REPORTED TO UKAB**

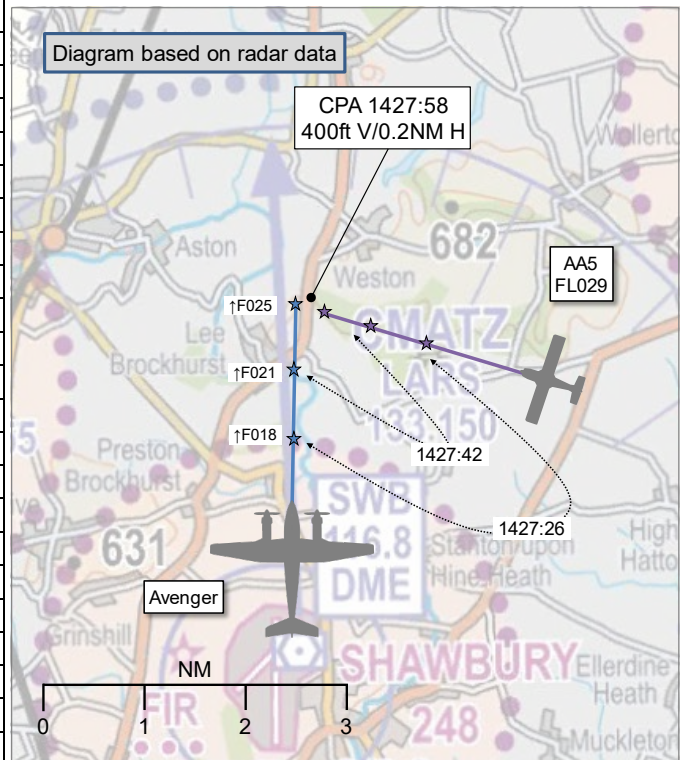
Recorded	Aircraft 1	Aircraft 2
Aircraft	Avenger	AA5
Operator	RN	Civ FW
Airspace	Shawbury CMATZ	Shawbury CMATZ
Class	G	G
Rules	VFR	VFR
Service	Traffic	Basic
Provider	Shawbury	Shawbury
Altitude/FL	FL025	FL029
Transponder	A, C, S+	A, C
<b>Reported</b>		
Colours	White, Blue	White
Lighting	NR	Strobe, Nav
Conditions	VMC	VMC
Visibility	>10km	>10km
Altitude/FL	2000ft	3100ft
Altimeter	QFE (1008hPa)	QNH
Heading	359°	280°
Speed	150kt	110kt
ACAS/TAS	TCAS II	Not fitted
Alert	RA	N/A
<b>Separation at CPA</b>		
Reported	300ft V/0m H	500ft V/150m H
Recorded	400ft V/0.2NM H
