AIRPROX REPORT No 2023125

Date: 11 Jun 2023 Time: 0929Z Position: 5318N 00247W Location: 2.5NM SE Liverpool Airport

PART A: SUMMARY OF INFORMATION REPORTED TO UKAB

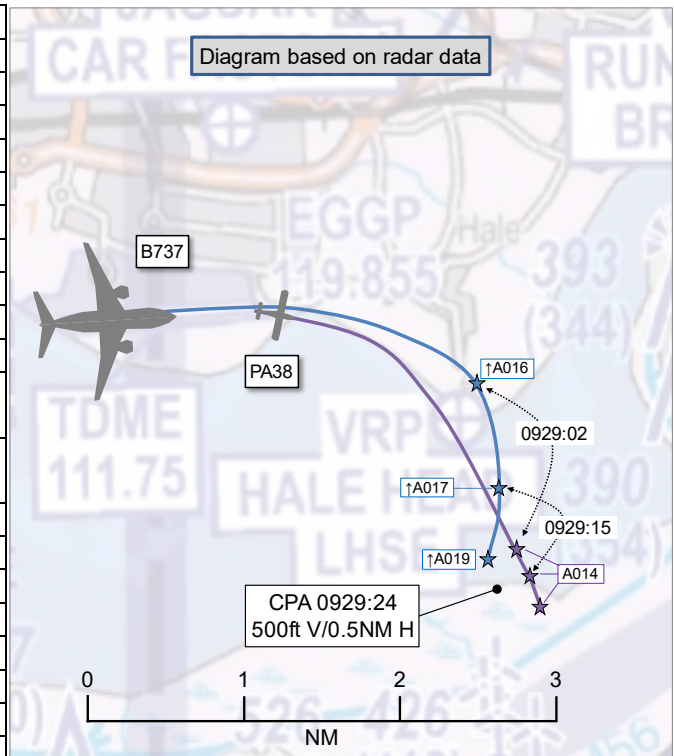
Recorded	Aircraft 1	Aircraft 2
Aircraft	B737	PA38
Operator	CAT	Civ FW
Airspace	Liverpool CTR	Liverpool CTR
Class	D	D
Rules	IFR	VFR
Service	ACS	ACS
Provider	Liverpool Tower	Liverpool Tower
Altitude/FL	1900ft	1400ft
Transponder	A, C, S+	A, C, S
Reported		
Colours	Blue and White	White and red with yellow trim.
Lighting	Strobe and anti-collision.	Anti-collision and nav lights
Conditions	VMC	VMC
Visibility	>10km	>10km
Altitude/FL	1770ft	NK
Altimeter	QNH (1015hPa)	QNH
Heading	Turning 210°	140°
Speed	NK	70kt
ACAS/TAS	TCAS II	Not fitted
Alert	RA	None
Separation at CPA		
Reported	NK V/NK H	800ft V/NK H
Recorded	500ft V/0.5NM H

Root Cause: Due to the noise preferential routing from RW09, all jet aircraft turn onto an outbound heading as soon as they have passed the end of the runway and passed 500ft. Therefore they are likely to be quite low when on the initial turn. Traffic was passed both ways between the [B737 pilot] and the [PA38 pilot]. However, [the B737 pilot] was cleared for take-off too soon after the [PA38] had got airborne on a similar route.

The investigator's recommendations were that ATCOs are to apply a little more caution when clearing much larger and faster IFR aircraft behind VFR aircraft when on similar routing and that it would be good for based [pilots] to be aware that if they are ever uncomfortable with the spacing between themselves and VFR aircraft (both arriving and departing), to inform ATC and larger spacing will be applied.
