**AIRPROX REPORT No 2023128**

Date: 21 Jun 2023 Time: 1045Z Position: 5212N 00010W Location: 2NM NW Gransden Lodge

**PART A: SUMMARY OF INFORMATION REPORTED TO UKAB**

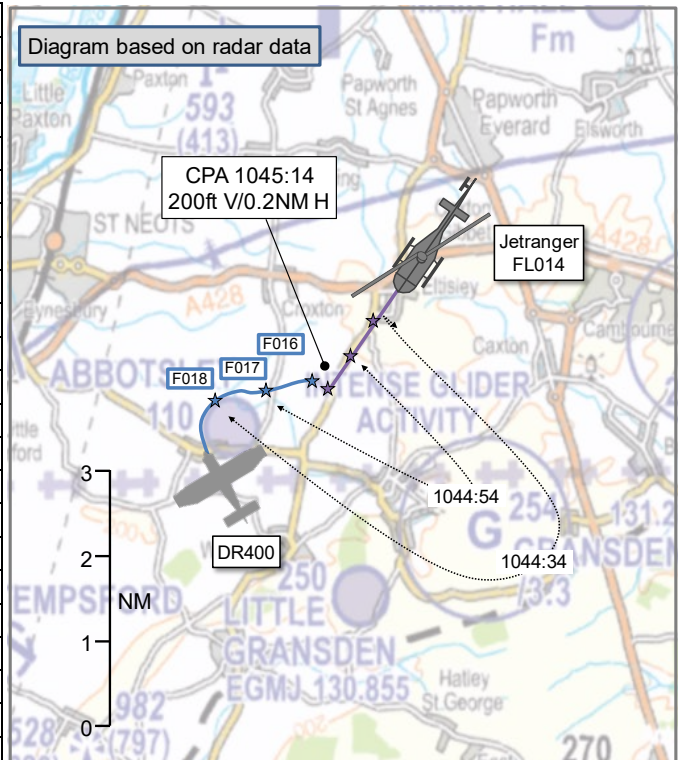
**THE DR400 PILOT** reports that at approximately 1148, whilst flying the downwind leg RW22 at Gransden Lodge at 600ft to the NW of site, they were confronted with a Bell Jetranger helicopter transiting NE/SW on reciprocal course on the inside of the circuit between the tug and the airfield. They turned to port to move away from the oncoming helicopter, which made no visible sign of seeing or reacting to the presence of the tug, even though both of the tug’s high intensity landing lights were on and pointing at the helicopter. The helicopter continued flying SW without deviation and overflew Little Gransden village and Little Gransden Airstrip [they believed], which was active. This was the second reportable Airprox at Gransden Lodge that morning, within ½ an hour of each other. FlightRadar 24 was checked and the tug course was seen, but there was no indication of the helicopter which appeared not to be transmitting.
