AIRPROX REPORT No 2023156

Date: 20 Jul 2023 Time: 1300Z Position: 5212N 00012E Location: Cambridge City Airport

PART A: SUMMARY OF INFORMATION REPORTED TO UKAB

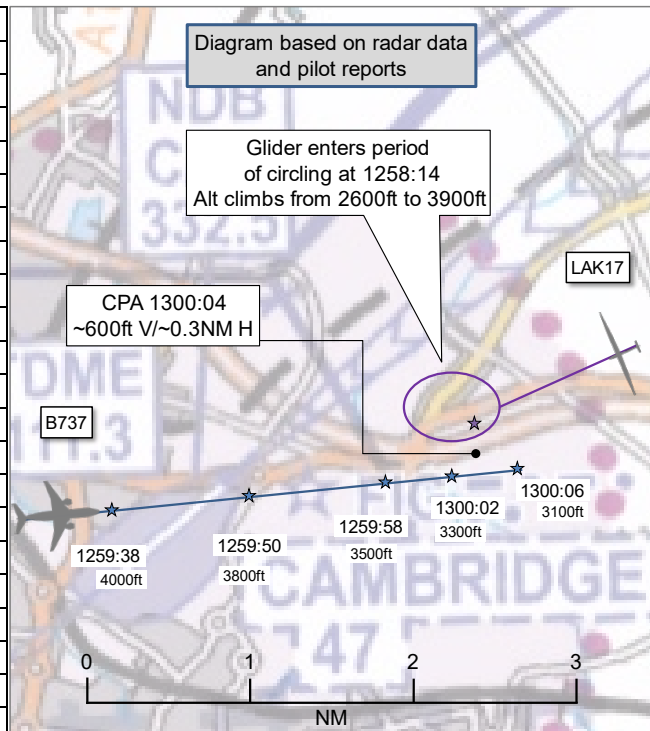
Recorded	Aircraft 1	Aircraft 2
Aircraft	B737	LAK17
Operator	Civ Comm	Civ Gld
Airspace	London FIR	London FIR
Class	G	G
Rules	IFR	VFR
Service	Procedural	Basic
Provider	Cambridge	Cambridge
Altitude/FL	3300ft	3900ft
Transponder	A, C, S+	A, C, S
Reported		
Colours	White	White
Lighting	Yes	Canopy strobe
Conditions	VMC	VMC
Visibility	5-10km	>10km
Altitude/FL	4000ft	3900ft
Altimeter	QNH (1015hPa)	QNH
Heading	087°	Circling
Speed	220kt	55kt
ACAS/TAS	TCAS II	FLARM
Alert	RA	None
Separation at CPA		
Reported	100ft V/0.2NM H	800ft V/0.5NM H
Recorded	~600ft V/~0.3NM H
