AIRPROX REPORT No 2023154

Date: 22 Jun 2023 Time: ~1007Z Position: 5021N 00442W Location: IVO St Austell

PART A: SUMMARY OF INFORMATION REPORTED TO UKAB

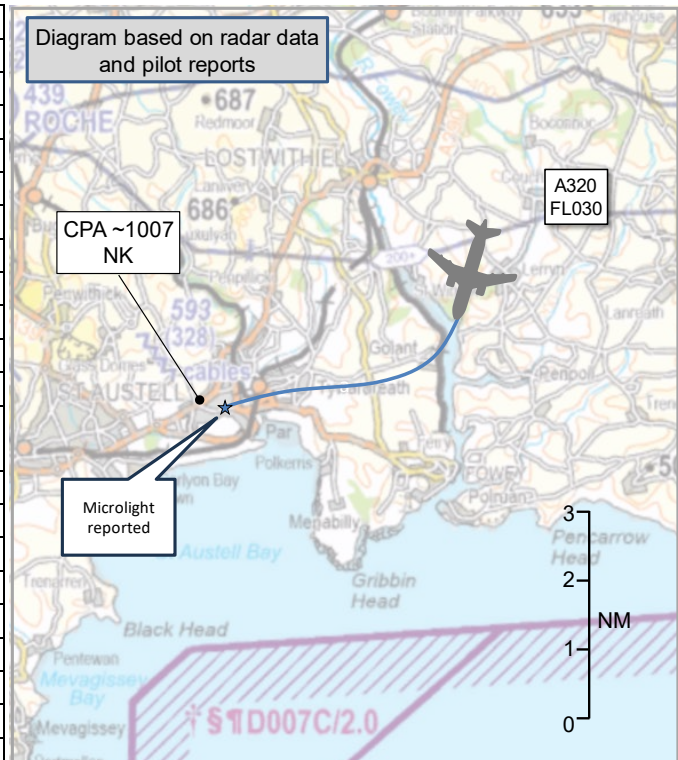
Recorded	Aircraft 1	Aircraft 2
Aircraft	A320	Unknown Microlight
Operator	CAT	Unknown
Airspace	London FIR	London FIR
Class	G	G
Rules	IFR	NK
Service	Deconfliction	Unknown
Provider	Newquay	
Altitude/FL	FL030	NK
Transponder	A, C, S+	None
Reported		
Colours	White, Green	
Lighting	Nav, Strobe, Landing	
Conditions	VMC	NK
Visibility	>10km	NR
Altitude/FL	3000ft	NK
Altimeter	AMSL	NK
Heading	260°	
Speed	240kt	
ACAS/TAS	TCAS II	Unknown
Alert	None	N/A
Separation at CPA		
Reported	0ft V/200-400m H	NK
Recorded	NK
