**AIRPROX REPORT No 2023178**

Date: 10 Aug 2023 Time: 1617Z Position: 5611N 00319W Location: 0.5NM E Portmoak

**PART A: SUMMARY OF INFORMATION REPORTED TO UKAB**

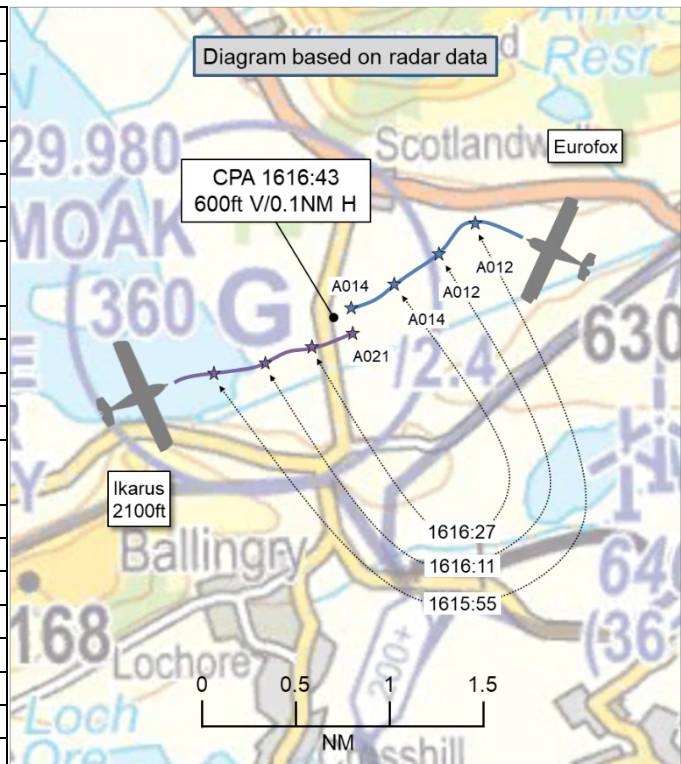
| Recorded | Aircraft 1 | Aircraft 2 |
|---|---|--|
| Recorded | 600ft V/0.1NM H | |

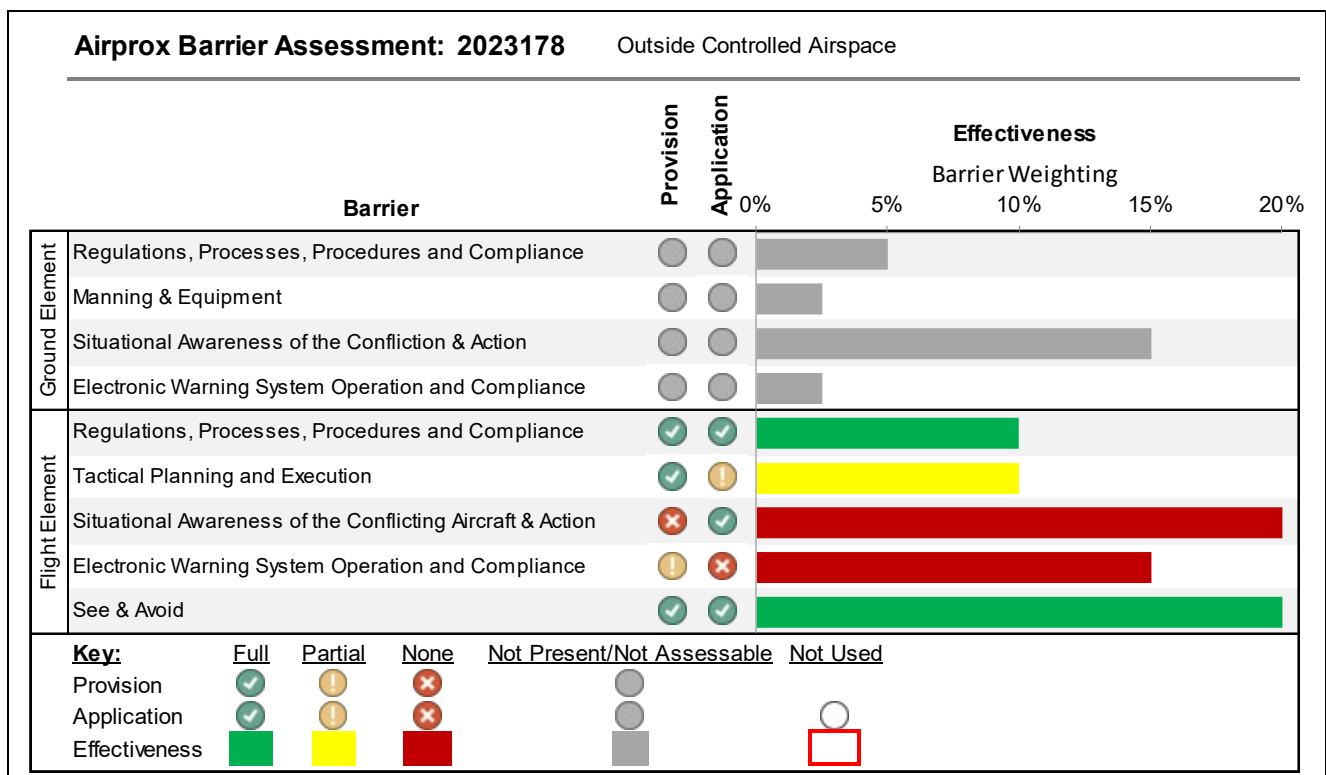
**Situational Awareness of the Conflicting Aircraft and Action** were assessed as **ineffective** because the pilot of the Eurofox had not had situational awareness of the presence of the Ikarus until it had been visually acquired.

**Electronic Warning System Operation and Compliance** were assessed as **ineffective** because the EC equipment fitted to the Eurofox would not have been expected to have detected the presence of the Ikarus. The EC equipment fitted to the Ikarus would have been expected to have detected the presence of the Eurofox but no alert was reported.
