AIRPROX REPORT No 2023158

Date: 21 Jul 2023 Time: ~0846Z Position: 5113N00134W Location: IVO Thruxton Aerodrome

PART A: SUMMARY OF INFORMATION REPORTED TO UKAB

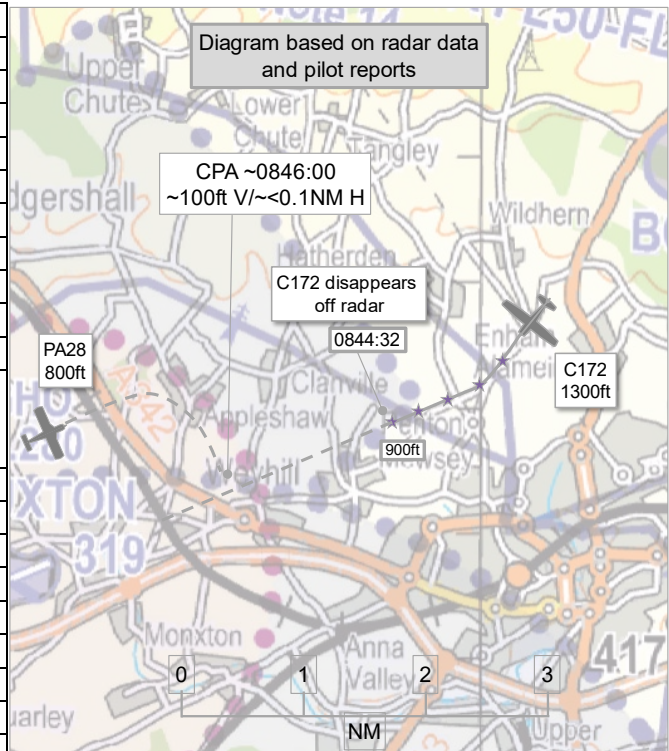
THE PA28 PILOT reports that, whilst they had been on the downwind leg, the C172 pilot called-in for a 5NM long final onto RW25 at [...]. Thruxton Radio responded with 1 in the circuit and the C172 pilot had said they would avoid the traffic. The PA28 pilot had slowed the plane to 75kts on the downwind leg to give more time for separation and extended the downwind leg. Shortly after turning onto base leg, the C172 appeared directly ahead at the same altitude passing from left-to-right at the closest distance of 400ft [they judged]. The C172 pilot then radioed 'I'm ahead' and proceeded on a short final. The PA28 pilot turned onto heading 250° and had then been directly behind the C172 and called for a go-around, passing overhead at 500ft as the C172 had touched down. After completing the sortie, their instructor (who had been watching from the tower) confirmed that they had acted in a safe and proper manner and that they should have had priority over the C172 with them conducting a safe join. A straight-in approach is not the standard join but is allowed when the circuit is free of traffic.

THE C172 PILOT reports that, on approach to [destination airfield] and [on changing from] the Boscombe Zone Frequency, the pilot had made contact with Thruxton Radio and requested airfield information and stated a preference for a straight in approach to RW25. They were advised that there had been one aircraft in the circuit and that they had been able to continue with a straight-in approach and that if necessary they should give way to circuit traffic. They continued their approach and recalled having heard the PA28 pilot calling downwind as they approached 2NM from the threshold. They continued to look for the PA28 in the circuit as they continued their approach, they had made visual contact as the PA28 approached the end of the downwind leg which they relayed to the A/G operator. They continued their approach and recalled having seen the PA28 turning onto base leg and at this stage they had been well in front and then at 1NM from the threshold. They announced that they had been visual with the aircraft on base leg and as they had been well ahead in the circuit they continued

The AGO recalls the C172 having joined straight-in for RW25 and having passed in front of the student pilot who had been on base leg. The student pilot in the PA28 elected to go around from their approach. The AGO states that they cannot be sure of any further radio conversations having taken place between themselves and the pilot of the C172 who continued their approach and then landed at 0848. The PA28 student pilot went around and had carried on with their circuit detail. The instructor of the student had been present in the tower and had spoken with the C172 pilot and asked them to come up to the tower to speak with the AGO. The AGO spoke to the pilot and advised them of the more correct join at Thruxton for RW25 when there was traffic in the circuit. The C172 pilot apologised and could see the action they should have taken - which was to have joined through the overhead giving way to circuit traffic.

Recommendation: The Thruxton airfield operator reviews their website and UK AIP entries to ensure coherence.
