AIRPROX REPORT No 2023167

Date: 04 Aug 2023 Time: 1222Z Position: 5129N 00114W Location: 1NM SSW CPT

PART A: SUMMARY OF INFORMATION REPORTED TO UKAB

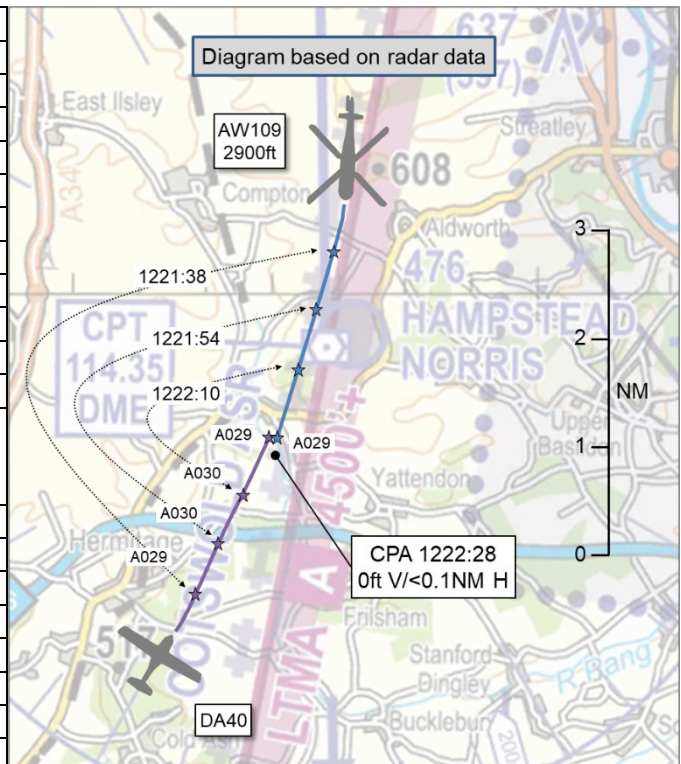
Recorded	Aircraft 1	Aircraft 2
Aircraft	AW109	DA40
Operator	Civ Helo	Civ FW
Airspace	London FIR	London FIR
Class	G	G
Rules	IFR	VFR
Service	Establishing contact	Establishing contact
Provider	Farnborough LARS	Oxford Radar
Altitude/FL	2900ft	2900ft
Transponder	A, C, S	A, C, S+
Reported		
Colours	Grey	White, light blue
Lighting	Landing, anti-col, position	Landing, taxi, nav, anti-col, HISL, strobes
Conditions	VMC	VMC
Visibility	>10km	NR
Altitude/FL	3000ft	3000ft
Altimeter	QNH (1018hPa)	QNH (1018hPa)
Heading	"south"	010°
Speed	120kt	115kt
ACAS/TAS	TAS	Not fitted
Separation at CPA		
Reported	0ft V/15m H	150ft V/100m H
Recorded	0ft V/<0.1NM H
