**AIRPROX REPORT No 2023176**

Date: 06 Aug 2023 Time: 0925Z Position: 5251N 00102W Location: Nottingham Heliport

**PART A: SUMMARY OF INFORMATION REPORTED TO UKAB**

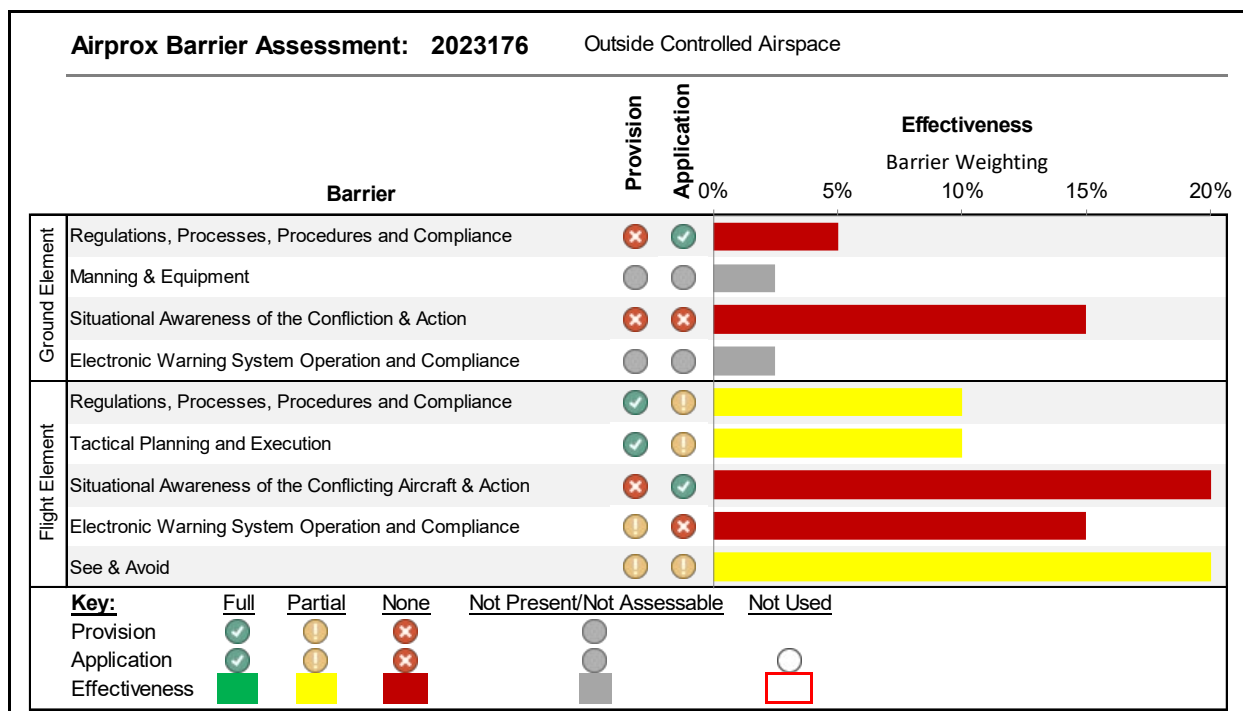
**Electronic Warning System Operation and Compliance** were assessed as **ineffective** because the DJI M300 'ADS-B In' did not detect the approaching AW109.

**See and Avoid** were assessed as **partially effective** because the AW109 pilot did not see the drone.
