AIRPROX REPORT No 2023186

Date: 19 Aug 2023 Time: 1053Z Position: 5211N 00005E Location: 3.5NM SSW Cambridge

PART A: SUMMARY OF INFORMATION REPORTED TO UKAB

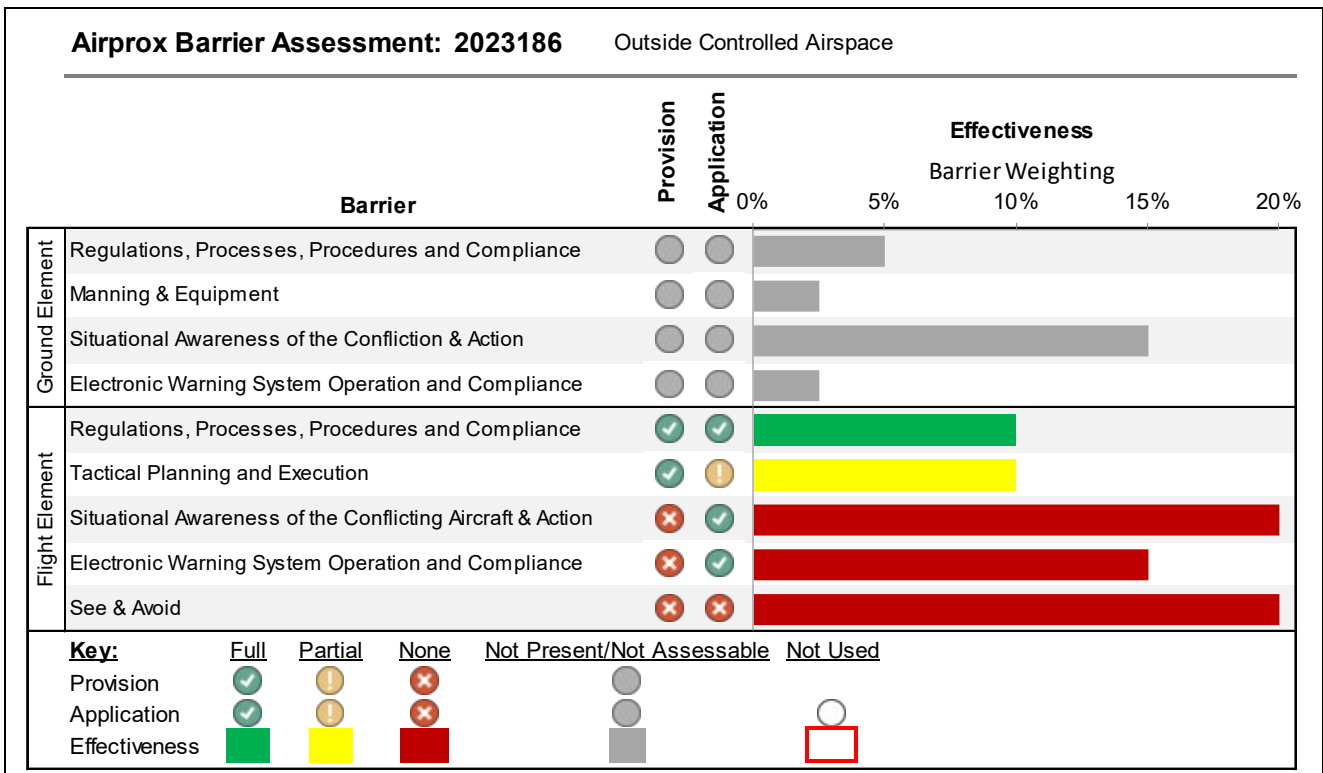
Electronic Warning System Operation and Compliance were assessed as **ineffective** because the EC device fitted to the C172 would not have been expected to have detected the presence of the Spitfire.

See and Avoid were assessed as **ineffective** because neither pilot had sighted the other aircraft before the moment of CPA.
