AIRPROX REPORT No 2023188

Date: 20 Aug 2023 Time: 1507Z Position: 5149N 00044W Location: Halton ATZ

PART A: SUMMARY OF INFORMATION REPORTED TO UKAB

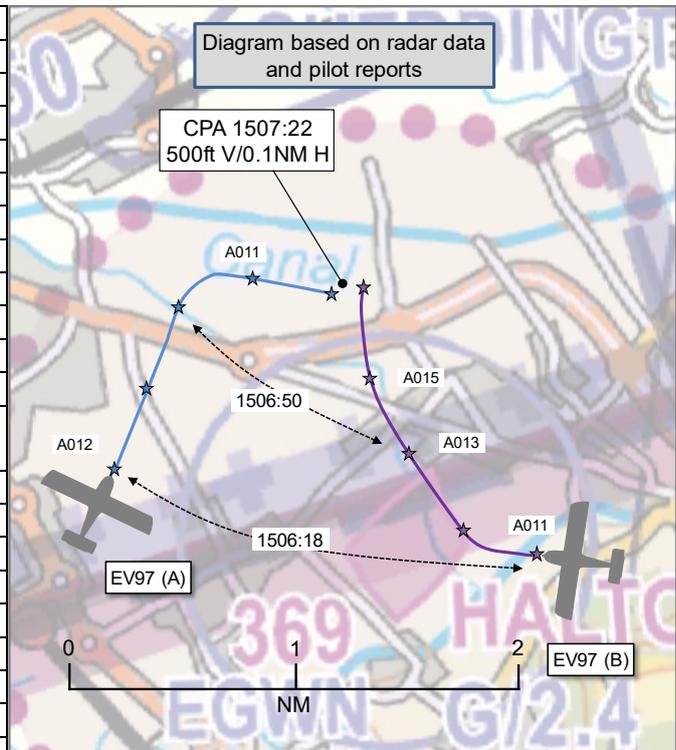
THE EV97(A) PILOT reports that they had been P/UT in EV97(A) completing differences training [they state that they are a PPL(A) holder] with the P1 and had been finishing their final lesson with circuit practice. They had completed 3 circuits up to that point on RW20RH at RAF Halton. They had been the only aircraft on frequency other than glider launch traffic calls which had not been a factor. The EV97(A) P/UT had called downwind for touch-and-go and continued their circuit. They then turned right base at which point both the EV97(A) P/UT and P1 had heard radio chatter between the glider launch site and Halton radio [they recalled as] "Halton Radio, Chilterns base" to which Halton Radio had replied "Chilterns, yes [...] visual". At that time, the EV97(A) pilots had not known what Halton Radio had been visual with but assumed it to have been a glider coming in to land. Both the EV97(A) P/UT and P1 had kept good lookout to where they had expected the glider to be, on left base RW20. No gliders had been seen so the EV97(A) P/UT had then started to focus on getting the aircraft configured for landing. It had been at this point that the EV97(A) P1 had seen the EV97(B) passing directly above them within a few hundred feet. The EV97(A) P1 had then checked if the P/UT had been happy to continue approach and the P/UT confirmed. The EV97(A) P1 had then communicated with Halton Radio to understand if they had the EV97(B) details to find out what had happened. During this time, the EV97(A) P/UT continued their approach and descended as normal for a touch-and-go on RW20. No radio calls had been heard from the EV97(B) pilot and it had [seemingly] just flown through the ATZ at [almost] circuit height.

THE EV97(B) PILOT reports that they had misidentified the airfield on the [moving map display] and had started to approach Halton as they had believed it to have been Wycombe. They had then switched radio frequency to Wycombe [recalling that that had been why they had not been on Halton Radio frequency and had reported their position according to [their moving map display] as they had not been visual with the runway at that time. The EV97(B) pilot had then continued to navigate following the

circuit pattern using the [moving map display] and when they had turned on to what they had believed to have been RW24 final position, they had noticed the EV97(A) below them and also the grass runways and the glider winched-off. The EV97(B) pilot had then immediately stopped the descent and realising that they had been lost, quickly turned right and started climbing to get out of [the Halton] ATZ ASAP.

THE HALTON AGO reports that the runway in-use at the time had been RW20RH with glider launches in progress and EV97(A) in the circuit. EV97(B) entered the Halton ATZ and had positioned downwind for RW25RH. EV97(A) had continued in the circuit and positioned for a final approach for RW25. The pilot had then initiated a go-around at approximately 800ft QNH and started a turning climb to the right. This turn had brought EV97(B) very close to the final/base leg for RW20 and EV97(A) who had been on right base at the time. During the climb-out, EV97(B) had been at approximately 1300ft and EV97(A) had been at approximately 900ft within 0.5NM. Glider launches had been in operation at the time and they use the LH circuit for RW20. EV97(B) would have been directly in the gliders operating side of the circuit during the downwind and final approach for RW25.
