AIRPROX REPORT No 2023191

Date: 28 Jul 2023 Time: 1401Z Position: 5627N 00315W Location: 7NM West of Dundee

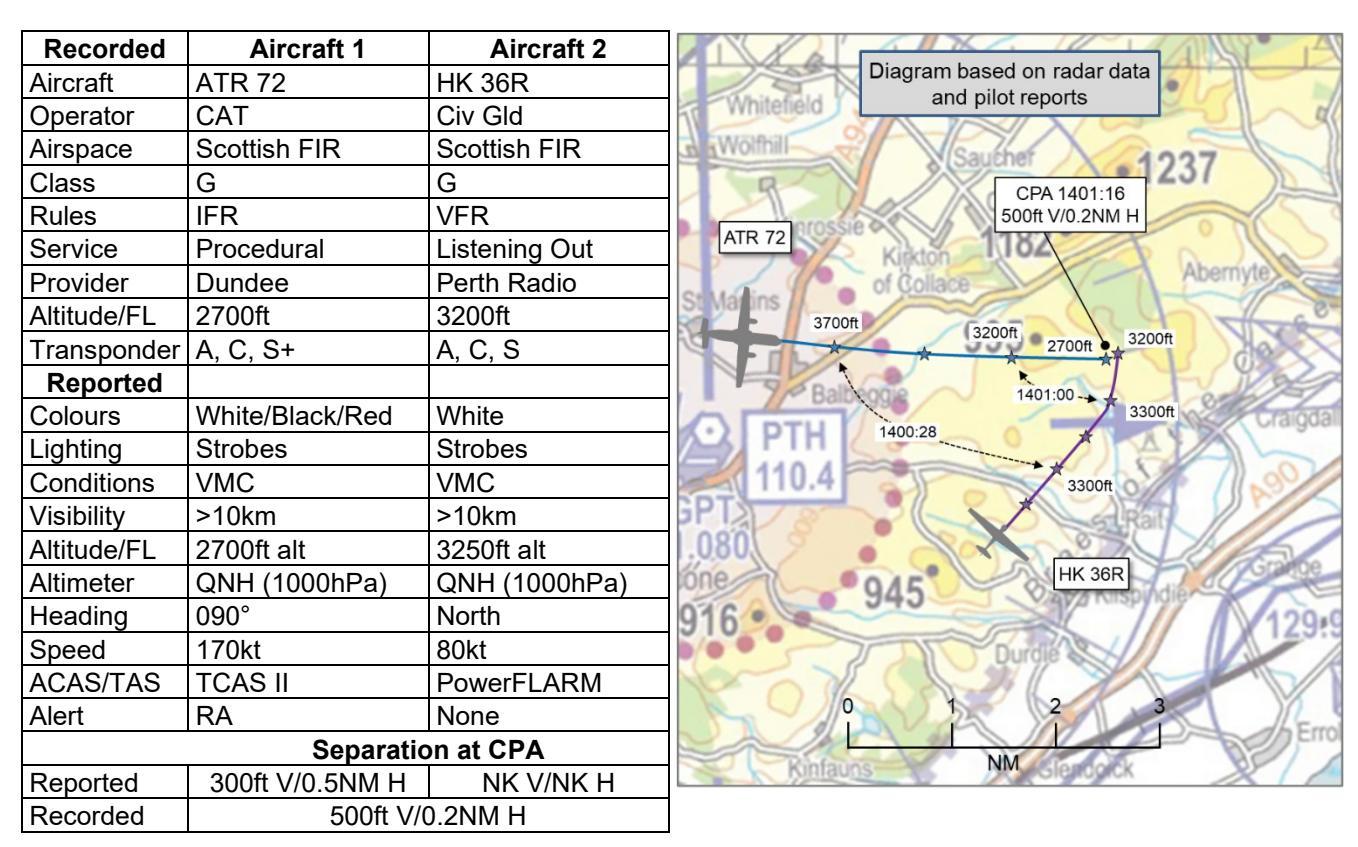
THE ATR 72 PILOT reports that they had been on approach into Dundee with multiple aircraft on TCAS in the surrounding area. They had been established for RW09 at around 6NM [and had] seen an aircraft on TCAS crossing the approach at approximately 2000-2200ft. A TCAS TA had appeared on screen and the aircraft identified visually. A TCAS RA was [triggered] with a descend command. After having moved clear of the aircraft and whilst still on approach for RW09 with no deviation out of limits, they made a decision to continue to land. The aircraft in question had been a DA40 [they recall] which, after talking with ATC in Dundee, they believed to be from [...]; its registration had been unknown as it had not been on frequency during the time.

THE HK 36R PILOT reports that they had been conducting a gliding exercise, for issue of the BGA Cross Country Endorsement. The route had been between BGA turning points PCS (Portmoak Caravan Site) and COU (Coupar Angus) with various intervals of simulating thermalling, field selection and landing exercises. The route chosen had been deliberately testing for the candidate [pilot], requiring them to navigate between Perth ATZ and the Errol drop zone and maintain awareness of the Dundee ILS. The gliding cross country frequency is 130.105MHz but, at the time of the incident, they had been passing close to Perth and the P2 had changed to that frequency to monitor. This had seemed to have been a good decision [at the time]. The pilots had discussed the various hazards in the pre-flight briefing, including the Dundee ILS feathers and the P2's plan had been to keep as far west of Dundee as possible. The reporting pilot notes that they had not been expecting approaches to Dundee from the west, given the wind had been south-westerly at about 15kts [noting that as a learning point for themselves]. The P1 had been mostly managing their altitude (though the P2 had been free to use lift, avoid sink etc) and they had climbed above 3000ft when they knew they had been close to the Dundee ILS, just to be on the safe side. The P2 had seen the aircraft converging from their left but the P1 had not. The P1 had assumed from the direction that the P2 had looked that it had been below and behind

on the left and thought it must be Perth traffic so the P1 had looked in that direction - hence missing it as it had passed underneath and continued to their right.

In conclusion, the TCAS RA generated on the ATR 72 had been caused by the close proximity of the HK 36R which had been transiting to the west of Dundee Airport to operate within the local area to the northwest of Dundee and at the time had not been in RT communication with either Leuchars LARS or Dundee ATC. This had been exacerbated by the ATR 72 having been higher on the approach than anticipated due to the late handover by TAY Sector, Prestwick Control to Leuchars LARS. In an open and honest report, the pilot of the HK 36R had deliberately planned the route to the area to the northwest of Dundee in order to fully test their student, as the route took the aircraft

RECOMMENDATION - It is recommended that the SATCO Dundee ATC contact the Portmoak Gliding Club in order to arrange a safety presentation highlighting procedures and operations into and out of Dundee Airport and to encourage any aircraft transiting close to Dundee Airport to contact Dundee ATC or Leuchars LARS via RTF. N.B. This brief was carried out on 13th January 2024.

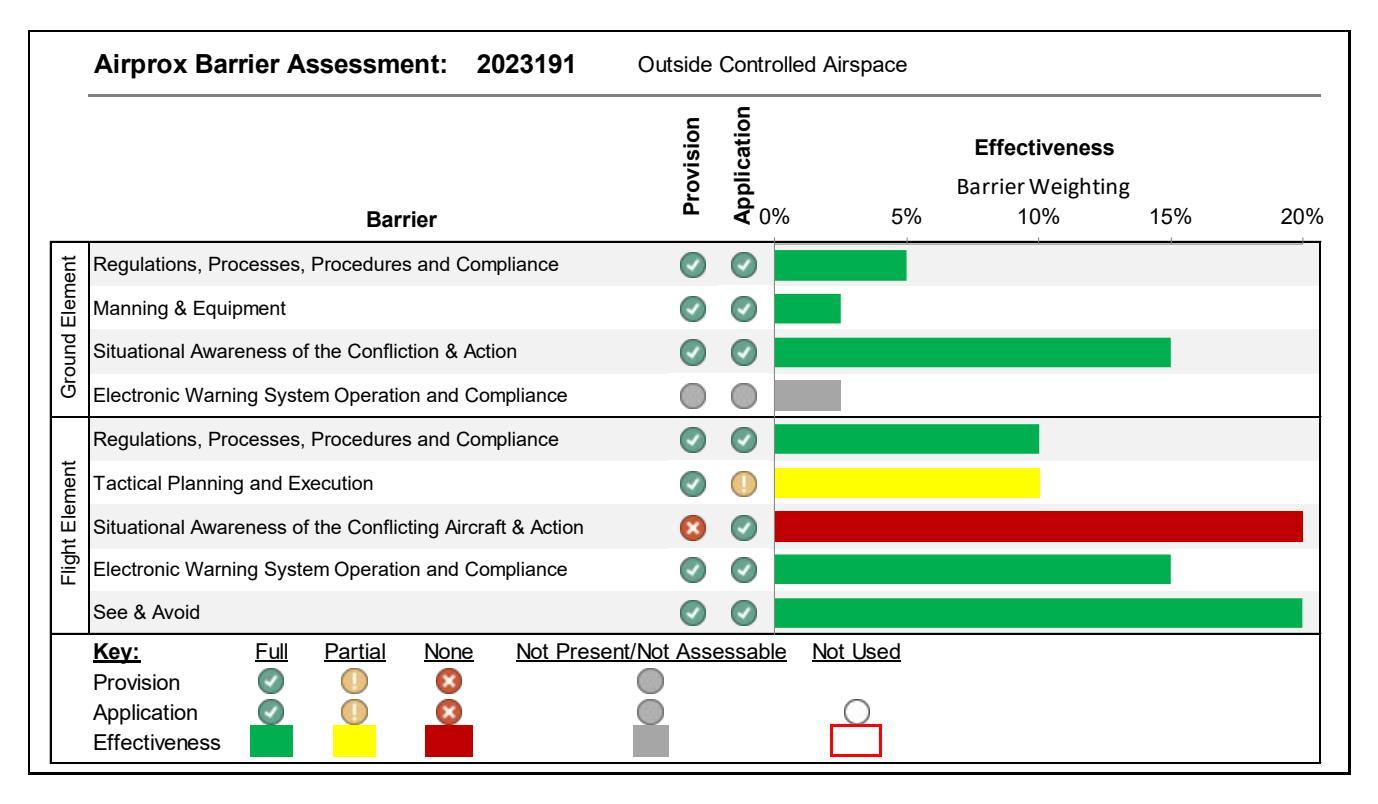
Tactical Planning and Execution was assessed as **partially effective** because the HK 36R pilot could have considered contacting Dundee as they had passed their approach lanes.

Situational Awareness of the Conflicting Aircraft and Action were assessed as **ineffective** because the HK 36R had no situational awareness of the ATR 72.
