AIRPROX REPORT No 2023187

Date: 20 Aug 2023 Time: 1353Z Position: 5208N 00037W Location: 4NM N Cranfield

PART A: SUMMARY OF INFORMATION REPORTED TO UKAB

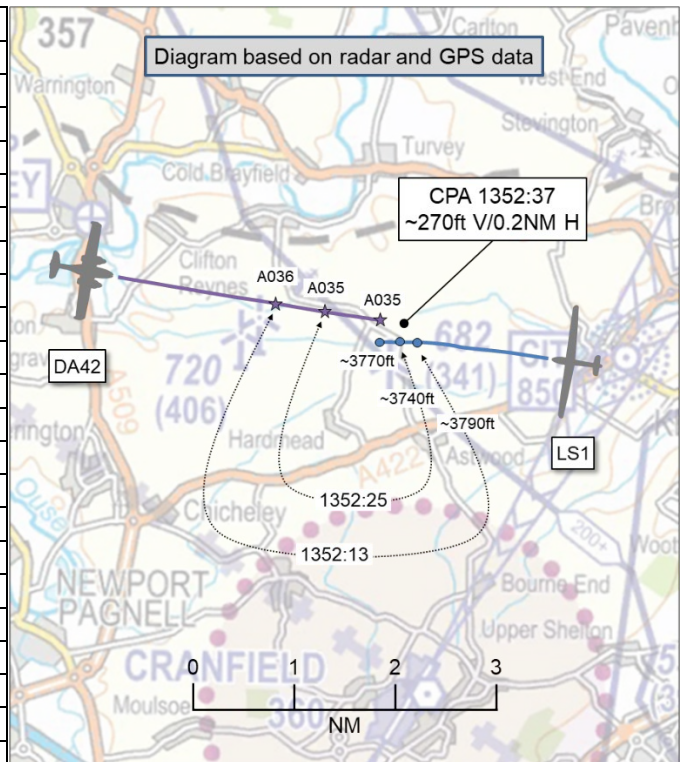
Recorded	Aircraft 1	Aircraft 2
Aircraft	LS1	DA42
Operator	Civ Gld	Civ FW
Airspace	London FIR	London FIR
Class	G	G
Rules	VFR	IFR
Service	None	Procedural
Provider	N/A	Cranfield Appr
Altitude/FL	~3770ft	3500ft
Transponder	Not fitted	A, C, S
Reported		
Colours	White, red	White
Lighting	None	Nav, position
Conditions	VMC	VMC
Visibility	5-10km	>10km
Altitude/FL	3600ft	3500ft
Altimeter	QNH	NK
Heading	"WSW"	100°
Speed	70kt	140kt
ACAS/TAS	FLARM	Not fitted
Alert	None	N/A
Separation at CPA		
Reported	0ft V/500m H	200ft V/1NM H
Recorded	~270ft V/0.2NM H
