AIRPROX REPORT No 2023202

Date: 02 Sep 2023 Time: ~1338Z Position: 5205N 00019W Location: Old Warden

PART A: SUMMARY OF INFORMATION REPORTED TO UKAB

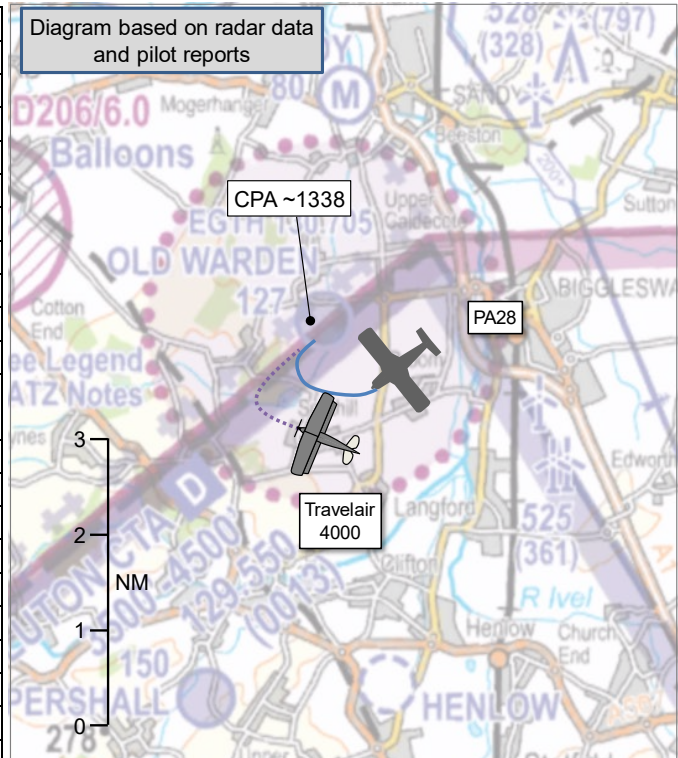
THE PA28 PILOT reports that they had departed Old Warden for a short local flight. On their return, they positioned for an overhead join for RW02RH at 1800ft AGL from the north. They made blind radio calls to Old Warden Traffic at 8NM, entering the zone, descending deadside, crosswind, downwind, base and final. Three other aircraft were also in the circuit on RT at the same time. After turning final, another aircraft transmitted 'Old Warden Traffic, two aircraft on short final!' The pilot saw no other aircraft in front of them, so they landed. As they were landing, they saw the shadow of another aircraft pass above them. After landing, the pilot of the other aircraft approached to ask why they had cut across them on final. They explained that they hadn't seen them or heard any RT calls from the other pilot. The other pilot said that they were non-radio and had flown a wide circuit for separation from the aircraft ahead of them. Although they [the PA28 pilot] had scanned final approach before turning, they did not see the other aircraft. They were primarily focussing on landing traffic ahead, so may not have given the lookout to long final enough attention. The pilot of the other aircraft stated that there was less than 200ft separation [they recalled] between them when they took avoiding action. Their aircraft is based at Old Warden, so they are very familiar with airfield operations.

THE TRAVELAIR 4000 PILOT reports that they were downwind for RW02 at Old Warden, non-radio, with a Tiger Moth ahead. They saw the PA28 joining via the deadside, apparently positioning to follow them downwind. The Tiger Moth flew a bigger than standard circuit, and thus they had to extend the downwind leg accordingly. As they turned base, the PA28 was downwind apparently following. On final their attention was focused on the Tiger Moth, which was occupying the runway. At about 300ft AGL, the PA28 appeared from behind their upper wing, cutting an estimated 200m in front. They overshot, and landed following an uneventful circuit. Following landing, they asked the PA28 pilot if they were aware of cutting them up, and how close they were. It transpired that the other pilot had been oblivious to their presence until they overshot above the PA28. Thus they had failed to see the Travelair 4000 at

any time when joining or in the circuit. The other pilot claimed they made 'all the right calls', but evidently didn't look for other traffic, as they had ample chance to see the Travelair 4000. With their own extension downwind, the PA28 pilot obviously flew a more standard pattern, ending up in front of their aircraft, descending ahead. With their attention on the Tiger Moth, the belief the PA28 pilot was following them and the upper wing (of their biplane) obscuring the PA28, they didn't see the other aircraft until late. Nevertheless, they noted that they could not see any flight path that could have been taken where the wing would have hidden the PA28 right until a collision occurred, hence their classification of risk as low. They accept that being non-radio compounded things, but the Old Warden flight guide entries specifically warn of non-radio aircraft, and radios do fail. Thus, they opined that reliance on RT alone for SA in the circuit is inadequate, lookout is essential. The incident was observed from the ground by the support crew of a glider preparing to launch, and they said the PA28 pilot simply flew a standard base to final in front of the Travelair 4000. By their own admission, the other pilot didn't at any point see the Travelair 4000 throughout any phase of the join, or subsequent circuit.
