## **AIRPROX REPORT No 2023200**

Date: 26 Aug 2023 Time: 1009Z Position: 5116N 00147W Location: 2NM NW Netheravon

# PART A: SUMMARY OF INFORMATION REPORTED TO UKAB

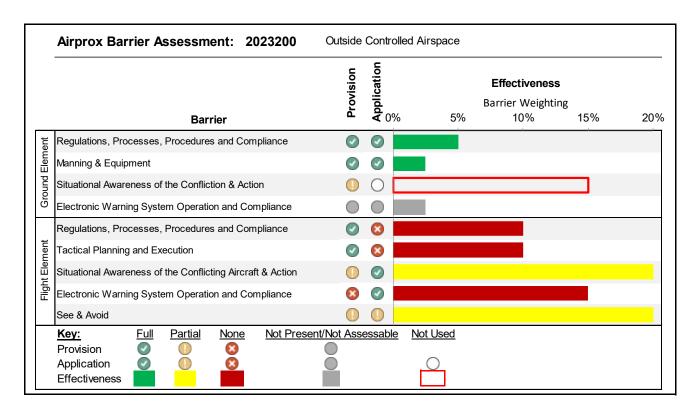
**See and Avoid** were assessed as **partially effective** because the C208 pilot saw the ASK21 likely at about CPA, effectively a non-sighting, and the ASK21 pilot saw the C208 at a late stage.
