AIRPROX REPORT No 2023199

Date: 28 Aug 2023 Time: 1346Z Position: 5107N 00031E Location: 4NM WSW of Headcorn

PART A: SUMMARY OF INFORMATION REPORTED TO UKAB

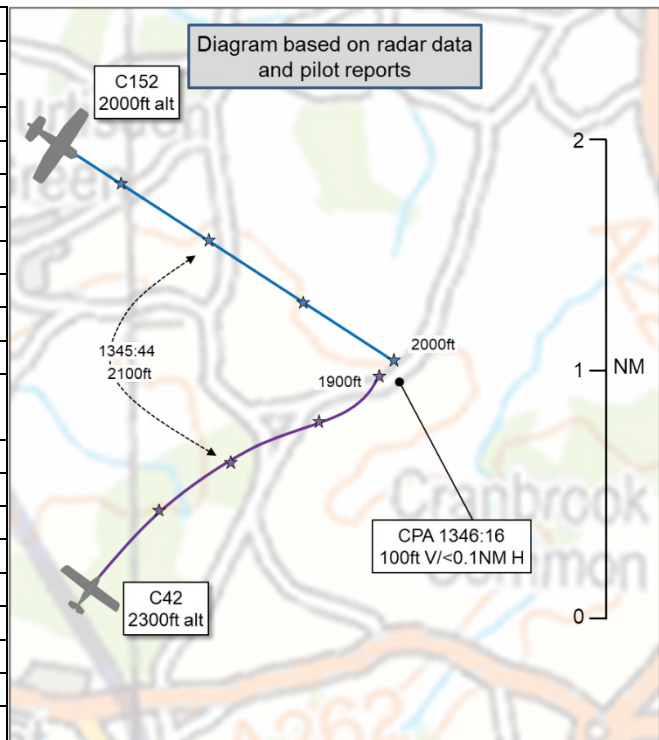
Recorded	Aircraft 1	Aircraft 2
Aircraft	C152	C42
Operator	Civ FW	Civ FW
Airspace	London FIR	London FIR
Class	G	G
Rules	VFR	VFR
Service	Basic	AGCS
Provider	Farnborough East	Headcorn
Altitude/FL	2000ft	1900ft
Transponder	A, C, S	A, C, S
Reported		
Colours	White with Blue and Red stripes	White with a Red tail
Lighting	Beacon	Strobes
Conditions	VMC	VMC
Visibility	>10km	>10km
Altitude/FL	2000ft	1900ft
Altimeter	QNH	QNH
Heading	~125°	030°
Speed	90kt	69kt
ACAS/TAS	Not fitted	Not fitted
Separation at CPA		
Reported	100ft V/0.5NM H	50ft V/100m H
Recorded	100ft V/<0.1NM H

At 1346:10 the minimum distance between the C152 and the unknown aircraft had been 0.12NM and both aircraft indicating 2000ft.
