**AIRPROX REPORT No 2023215**

Date: 06 Sep 2023 Time: 1401Z Position: 5052N 00314W Location: Dunkeswell

**PART A: SUMMARY OF INFORMATION REPORTED TO UKAB**

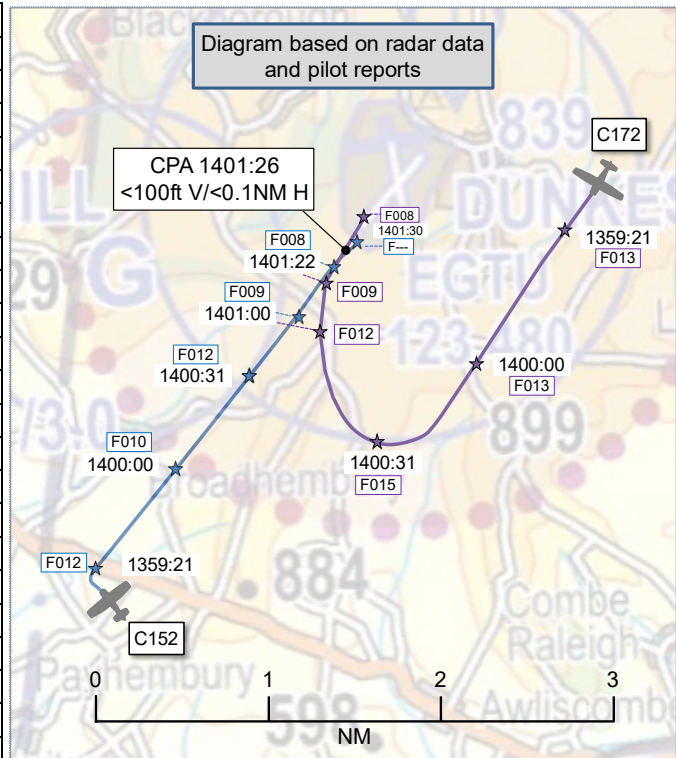
Recorded	Aircraft 1	Aircraft 2
Aircraft	C152	C172
Operator	Civ FW	Civ FW
Airspace	Dunkeswell ATZ	Dunkeswell ATZ
Class	G	G
Rules	VFR	VFR
Service	AGCS	AGCS
Provider	Dunkeswell Radio	Dunkeswell Radio
Altitude/FL	FL008	FL009
Transponder	A, C	A, C
Reported		
Colours	White	White
Lighting	NA	NK
Conditions	VMC	VMC
Visibility	>10km	>10km
Altitude/FL	3ft	NK
Altimeter	QFE	NK
Heading	040°	040°
Speed	60kt	65kt
ACAS/TAS	Not fitted	Unknown
Alert	N/A	Unknown
Separation at CPA		
Reported	10ft V/4m H	NK V/NK H
Recorded	<100ft V/<0.1NM H
